EASA Safety Information Bulletin

SIB No.: 2011-02
Issued: 18 March 2011

Subject: **ATR Main Landing Gear (MLG) Shock Absorbers – Cross Locking Bolt of the Attachment Pin**

Applicability: ATR 42 and ATR 72 aeroplanes, all models, all serial numbers.

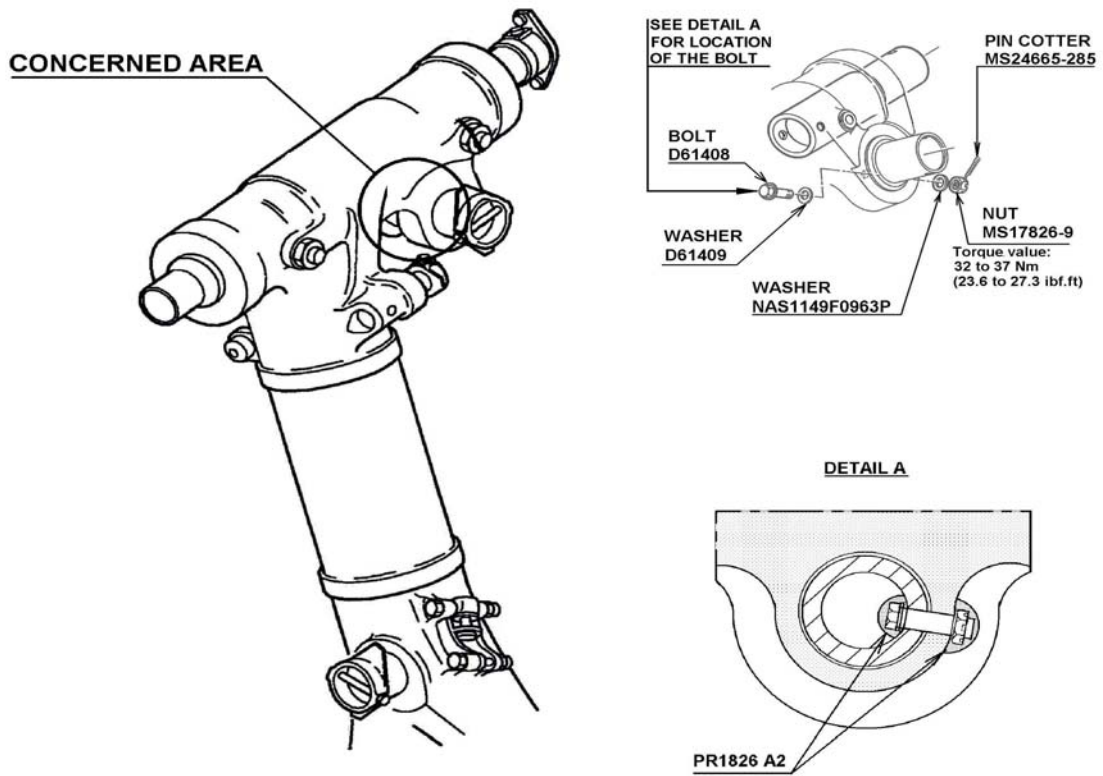
MLG leg structure of ATR72 - ALL MODELS

Recently, one operator reported that during a routine inspection, the shock absorber was found migrated from the MLG barrel assembly location. The report highlighted that the locking bolt which secures the shock absorber hinge pin was missing. Further investigation revealed that the locking bolt was not installed during barrel assembly replacement, despite the specific caution incorporated in the CMM.

need of strictly following the instructions provided in the applicable M-D CMM and of installing the locking bolt, thereby preventing partial loosening of the shock absorber at the upper attachment hinge.

- MLG barrel replacement should only be performed in an approved repair shop.
- The latest issue (revision) of any applicable CMM should be used to accomplish MLG maintenance.
- Local Instruction Cards used in the repair shop should be updated to correspond with the applicable CMM build-up instructions.
- The repair shop should confirm the presence of the locking bolt of the shock absorber upper attachment pin in accordance with the instructions of MD SB 631-32-190.
