EASA	EMERGENCY AIRWORTHINESS DIRECTIVE

<p style="text-align: center;">EAD No : 2007-0234 R1-E</p> <p style="text-align: center;">Date: 10 September 2007</p>	
No person may operate an aircraft to which an Airworthiness Directive applies, except in accordance with the requirements of that Airworthiness Directive unless otherwise agreed with the Authority of the State of Registry.		
Type Approval Holder's Name :	Type/Model designation(s) :	
The Boeing Company	737 series aircraft	
TCDS Number: FAA (USA) Nr. A16WE		
Foreign AD: FAA Emergency Airworthiness Directive (EAD) 2007-18-52, issued 28 August 2007		
Revision: This EAD revises EASA EAD 2007-0234-E dated 29 August 2007.		
For aircraft operated under EU regulations, the requirements of this EAD take precedence over those contained in FAA EAD 2007-18-52.		
ATA 57	Wings – Slat Track Downstop Assembly & Parts – Inspection / Repair / Replacement	
Manufacturer(s):	Boeing Airplane Company

AD 2007-18-52; FAA-2007-29089; Directorate Identifier 2007-NM-215-AD

2007-18-52 BOEING: Docket No. FAA-2007-29089; Directorate Identifier 2007-NM-215-AD.

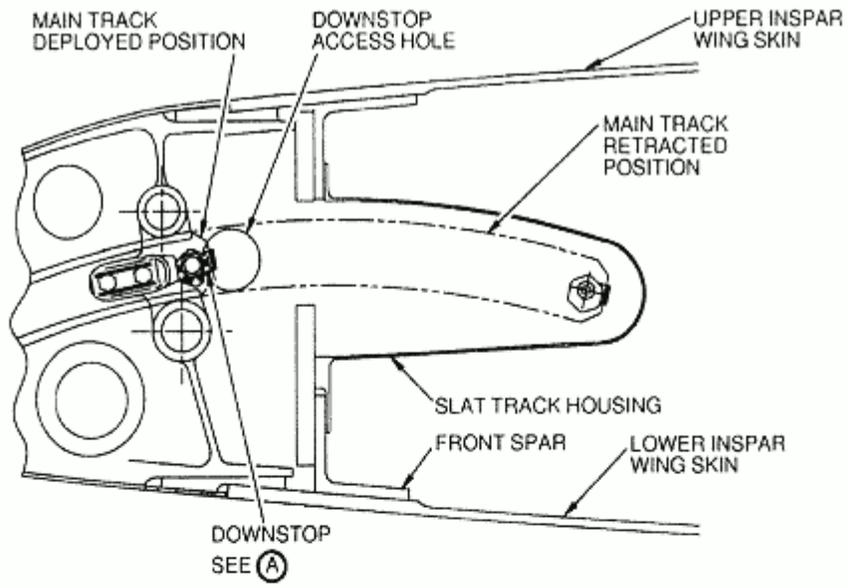
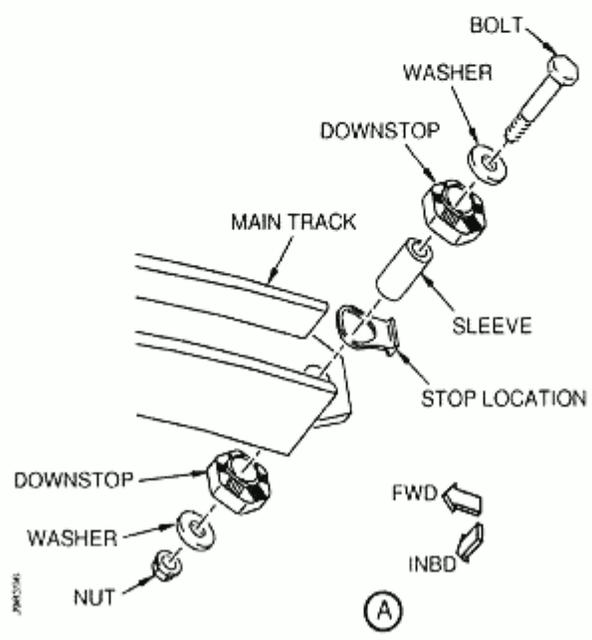
That AD resulted from reports of parts of the main slat track downstop assembly coming off the main slat track. In one case, a nut fell into the slat track housing (referred to as "slat can") and, during a subsequent slat retraction, the track made contact with the nut, pushing it into the wall of the can and puncturing it. That operator reported finding fuel leaking from the drain hole in the slat track housing at the No. 5 slat track position. In another case, an initial investigation revealed that following retraction of the slats after landing on a Model 737-800 airplane, loose parts of the main slat track downstop assembly punctured the slat can, which resulted in a fuel leak and a fire that ultimately destroyed the airplane. We issued that AD to detect and correct loose or missing parts from the main slat track downstop assemblies, which could result in a fuel leak and consequent fire.

(d) This AD results from additional reports of parts coming off the main slat track downstop assemblies. We are issuing this AD to detect and correct loose or missing parts from the main slat track downstop assemblies, which could result in a fuel leak and consequent fire.

Slat Track Downstop Assembly

(f) Within 10 days after receipt of this AD: Do a detailed inspection or a borescope inspection of each main slat track downstop assembly to verify proper installation of the slat track hardware (i.e., the bolt, washers, downstops, stop location, and nut shown in Figure 1 of Boeing Service Letter 737-SL-57-084-B, dated July 10, 2007, and in this AD). Proper installation of the sleeve need not be confirmed, and the stop location part may be installed on either the inboard or the outboard side of the slat track. If any part is missing or is installed improperly, before further flight, install a new or serviceable part using a method approved in accordance with the procedures specified in paragraph (h) of this AD; and do a detailed inspection of the inside of the slat can for foreign object debris (FOD) and damage. Before further flight, remove any FOD found and repair any damage found using a method approved in accordance with the procedures specified in paragraph (h) of this AD. Using Boeing Multi Operator Message Number 1-523812011-1, issued August 25, 2007; or 1-527463441-1, issued August 28, 2007; is one approved method for verifying proper installation; installing a new or serviceable part; and inspecting for damage and FOD, and removing FOD and repairing damage. Repeat the actions required by paragraph (f) of this AD thereafter at intervals not to exceed 3,000 flight cycles.

(g) Within 24 days after receipt of AD 2007-18-51: Apply a torque between 50 to 80 inch-pounds to the nut. The bolt head must be held with the torque applied to the nut.
