## PŘÍKAZ K ZACHOVÁNÍ LETOVÉ ZPŮSOBILOSTI

**Číslo: 2007-0234 R1-E**

řada 737, modely 737-600, -700, -800, -900

<p style="text-align: center;"><b>EAD No : 2007-0234 R1-E</b></p> <p style="text-align: center;"><b>Date: 10 September 2007</b></p>	
No person may operate an aircraft to which an Airworthiness Directive applies, except in accordance with the requirements of that Airworthiness Directive unless otherwise agreed with the Authority of the State of Registry.		
<b>Type Approval Holder's Name :</b>	<b>Type/Model designation(s) :</b>	
The Boeing Company	737 series aircraft	
TCDS Number: FAA (USA) Nr. A16WE		
Foreign AD: FAA Emergency Airworthiness Directive (EAD) 2007-18-52, issued 28 August 2007		
Revision: This EAD revises EASA EAD 2007-0234-E dated 29 August 2007.		
For aircraft operated under EU regulations, the requirements of this EAD take precedence over those contained in FAA EAD 2007-18-52.		
<b>ATA 57</b>	<b>Wings – Slat Track Downstop Assembly &amp; Parts – Inspection / Repair / Replacement</b>

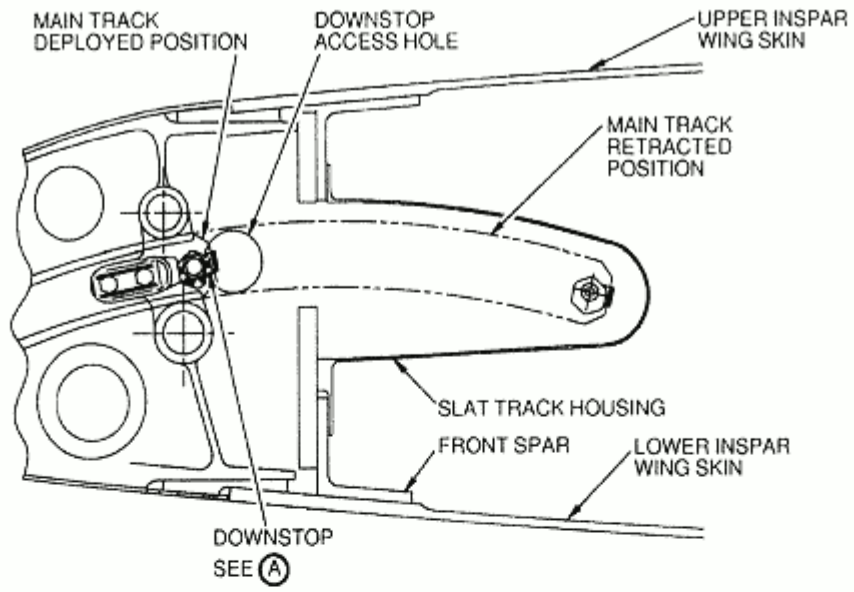
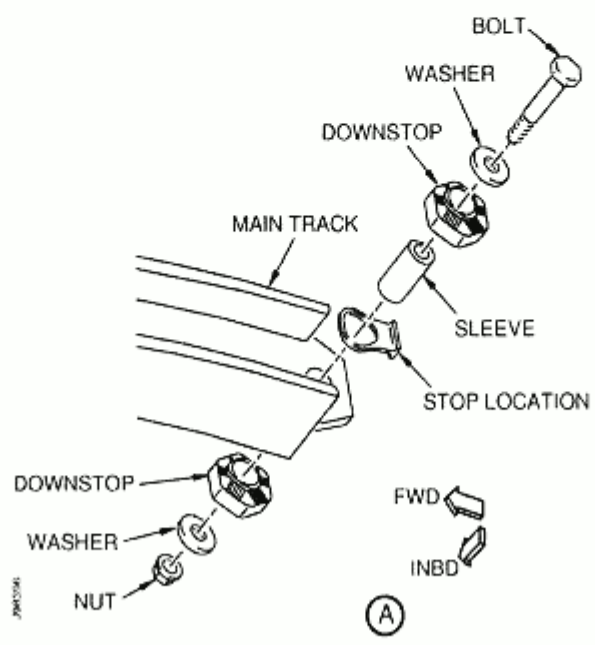
**Figure 1**

(f) Within 10 days after receipt of this AD: Do a detailed inspection or a borescope inspection of each main slat track downstop assembly to verify proper installation of the slat track hardware (i.e., the bolt, washers, downstops, stop location, and nut shown in Figure 1 of Boeing Service Letter 737-SL-57-084-B, dated July 10, 2007, and in this AD). Proper installation of the sleeve need not be confirmed, and the stop location part may be installed on either the inboard or the outboard side of the slat track. If any part is missing or is installed improperly, before further flight, install a new or serviceable part using a method approved in accordance with the procedures specified in paragraph (h) of this AD; and do a detailed inspection of the inside of the slat can for foreign object debris (FOD) and damage. Before further flight, remove any FOD found and repair any damage found using a method approved in accordance with the procedures specified in paragraph (h) of this AD. Using Boeing Multi Operator Message Number 1-523812011-1, issued August 25, 2007; or 1-527463441-1, issued August 28, 2007; is one approved method for verifying proper installation; installing a new or serviceable part; and inspecting for damage and FOD, and removing FOD and repairing damage. Repeat the actions required by paragraph (f) of this AD thereafter at intervals not to exceed 3,000 flight cycles.

**Slat Track Downstop Assembly**

(g) Within 24 days after receipt of AD 2007-18-51: Apply a torque between 50 to 80 inch-pounds to the nut. The bolt head must be held with the torque applied to the nut.
