**SUBJ: Wings - PA-28, PA-32, PA-34, and PA-44 Rear Spar
Corrosion at Fuselage Attach Fitting**

**SAIB: CE-11-12
Date: January 5, 2011**

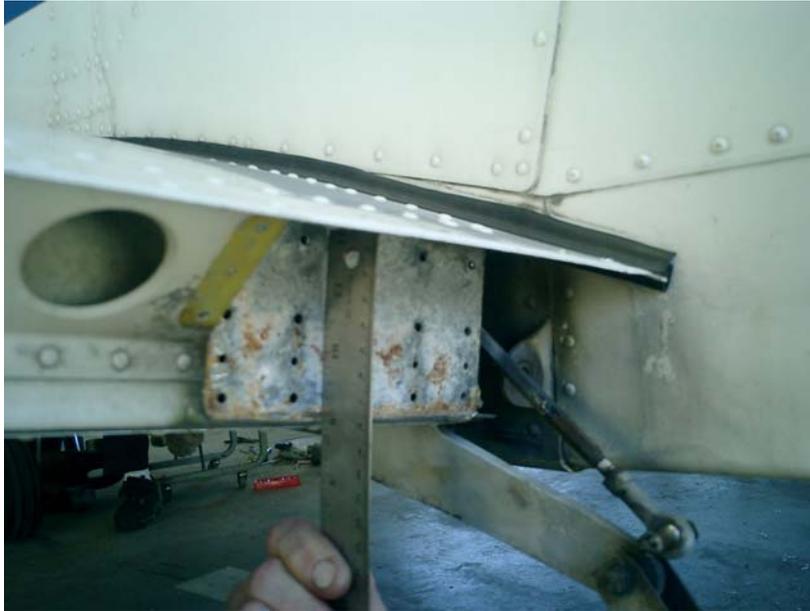
This information is presented in response to service data showing extensive corrosion on the wing rear spar at the fuselage attach fitting of Piper PA-28 and PA-32 aircraft. See Figure 1 below as an example. The example damage was found during routine maintenance affecting the part number 66762-00 plate, 62448-02/03 fitting, and 35174-04/05 aft spar. Note: The steel plate 66762-00 is common to all PA-28, PA-32, PA-34, and PA-44 aircraft, though the aluminum aft spar part number may vary.

There are other factors affecting the issue. First, we have received reports of improper paint stripping that leaves potentially corrosive chemical residue on these wing spars. All reported occurrences have included damage to only one wing on the affected aircraft. Finally, aircraft with retractable gear (e.g., PA-28R) are more difficult to inspect from the forward side of the spar due to the main landing gear wheel well.

The FAA recommends that owners and operators incorporate the actions in Piper SBs 789A, 977, and 1006 based on the effectivity of the individual SB. Due to similarity of design (steel plate 66762-00 adjacent to aluminum spar) and since improper maintenance or painting procedures have been a contributing factor in past service reports, all PA-28, PA-32, PA-34, and PA-44 aircraft are susceptible to this corrosion development. Therefore, the inspections in the SBs should be implemented for all PA-28, PA-32, PA-34, and PA-44 models. We recommend that all the actions be taken within 100 hours. We further recommend inspection and incorporation as soon as feasible, but no more than 100 hours, for those aircraft at higher risk due to age, environment, lack of protective coatings, etc., as discussed above.

If damage is found, a Malfunction / Defect Report or Service Difficulty Report (SDR) should be filed. The SDR system is available at <http://av-info.faa.gov/sdrx/>. There are currently no established allowable limits on the subject parts so repair or replacement will be necessary if damage is found.
