EASA Safety Information Bulletin

SIB No.: 2011-09
Issued: 17 May 2011

- Subject:** **Pilot Response to Propeller Overspeed in Piston Engine Aeroplanes**
- Ref. Publications:** Federal Aviation Administration (FAA) Special Airworthiness Information Bulletin (SAIB) CE-10-21 dated 17 March 2010.

SUBJ: Propellers/Propulsers; Propeller Overspeed in Piston Engine Aircraft

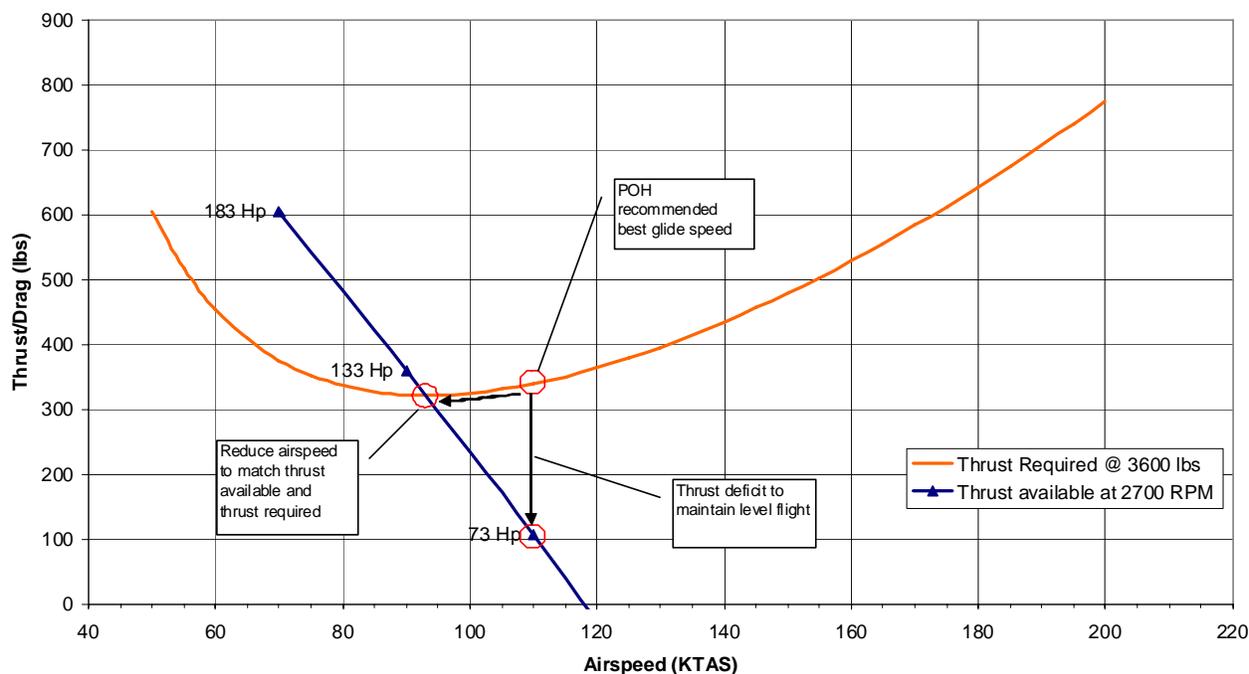
Example of Propeller Operation on Low Pitch Stop Estimated Thrust/Drag vs. Airspeed

The graph below shows thrust versus airspeed for a typical propeller model set at a 12-degree blade angle and maintaining 2,700 revolutions per minute (RPM). From the graph, note that at over 118 knots this propeller is incapable of generating a positive thrust and airspeed has to be lower than 95 knots to generate enough thrust to overcome the aircraft drag, i.e. maintain level flight. While different propeller models have different thrust characteristics and different aircraft have different drag characteristics, the concept remains the same – the lower the airspeed the more thrust there is available at a given RPM.

Gear & Flaps Up
1000 ft., Standard Day
Propeller on Low Pitch Stop of 12 Degrees

advise the pilot to control a propeller overspeed by throttle reduction and a reduction in airspeed as much as practical with an adequate margin above stall speed such that level flight can be maintained.

The operators of aircraft with variable pitch propellers should be aware that in certain instances of propeller overspeed, the airspeed necessary to maintain level flight may be different than the speed associated with engine-out best glide speed. The appropriate emergency procedures should be followed to mitigate the emergency situation in the event of a propeller overspeed; however, pilots should be aware that some reduction in airspeed may result in the ability for continued safe flight and landing. The determination of an airspeed that is more suitable than engine-out best glide speed should only be conducted at a safe altitude when the pilot has time to determine an alternative course of action other than landing immediately.
