PŘÍKAZ K ZACHOVÁNÍ LETOVÉ ZPŮSOBILOSTI

Číslo: CAA-AD-039/2004

Engine Components Incorporated (ECi)
Teledyne Continental Motors řada 520,
550

MOTOR – HLAVA VÁLCE – KONTROLA/VÝMĚNA

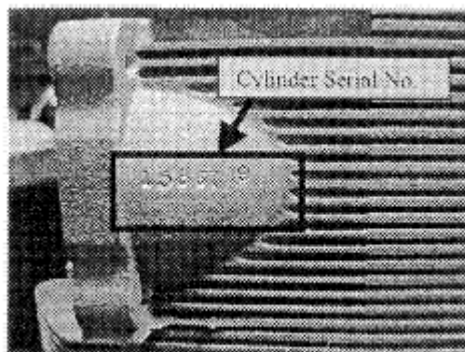
Figure 1.

(i) Determine the SN of the cylinder by looking in the engine records or by inspecting the cylinder for a SN on the intake port boss (see Figure 1) or on the flat area next to the head to barrel junction (see Figure 2). Disregard any dash numbers that might follow the four digit SN.

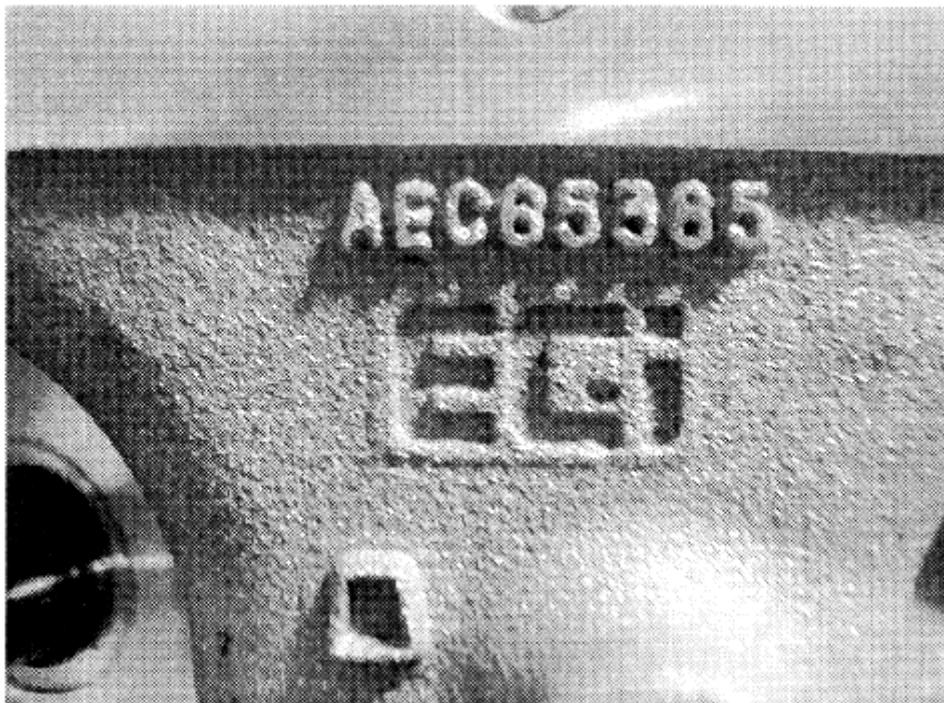
(iii) If the casting has AEC65385, and an "O" under the ECI logo, the cylinder is P/N AEC631397. See Figure 3.

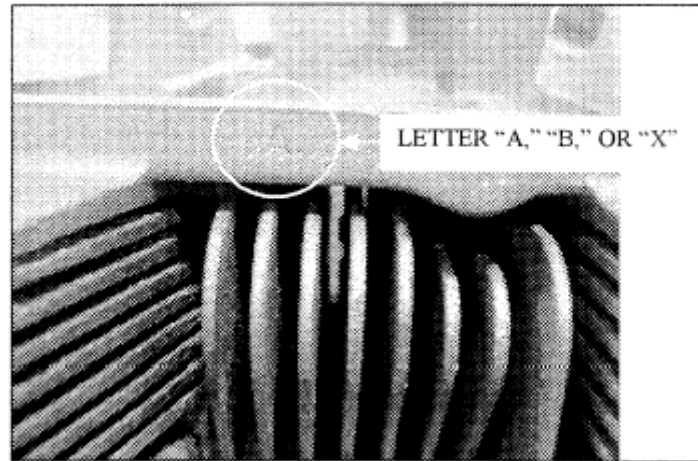
(ii) If there is a letter "A," "B," or "X" stamped on the flange of the rocker box, no further action is required. See Figure 4.

(iii) If there is no letter "A," "B," or "X" stamped on the flange of the rocker box, replace the cylinder before further flight.
