AIRWORTHINESS DIRECTIVE

Number: CAA-AD-039/2004

Engine Components Incorporated (ECi)
Teledyne Continental Motors model 520,
550

ENGINE – CYLINDER HEAD – INSPECTION/REPLACEMENT

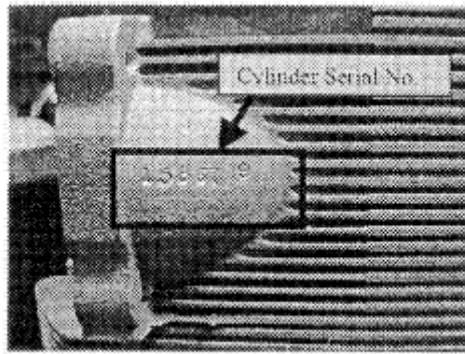
Figure 1.

(i) Determine the SN of the cylinder by looking in the engine records or by inspecting the cylinder for a SN on the intake port boss (see Figure 1) or on the flat area next to the head to barrel junction (see Figure 2). Disregard any dash numbers that might follow the four digit SN.

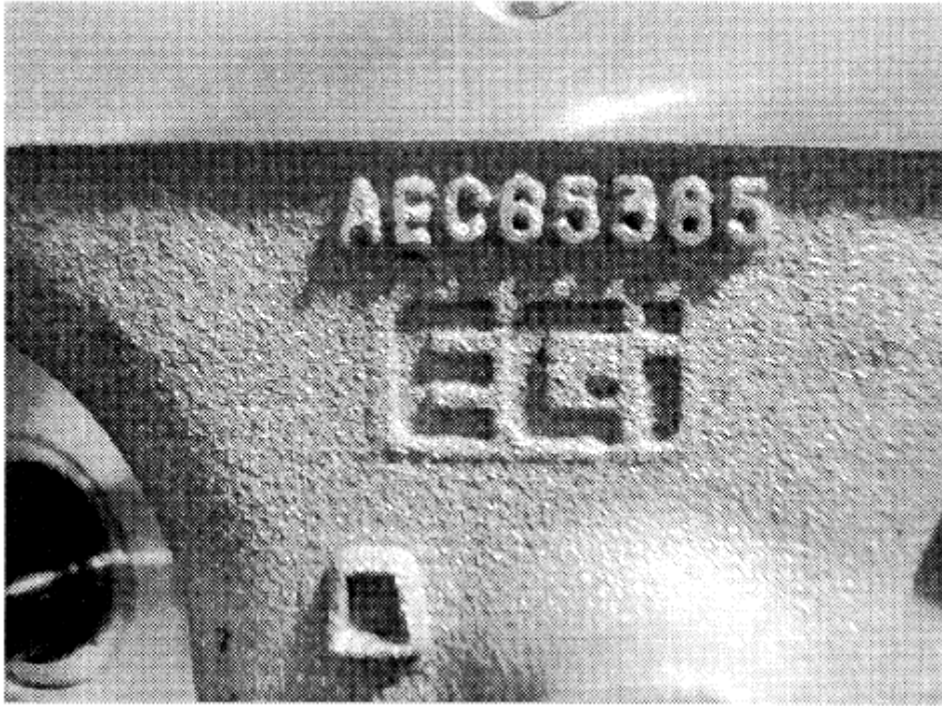
- (ii) If the SN is 1043 or lower, or if it is 7709 or higher, no further action is required.
- (2) If the cylinder SN is 1044 through 7708, do the following:
 - (i) Remove the rocker box cover from the cylinder.
 - (ii) Look at the left-front cylinder casting.
 - (iii) If the casting has AEC65385, and an "O" under the ECi logo, the cylinder is P/N AEC631397. See Figure 3.

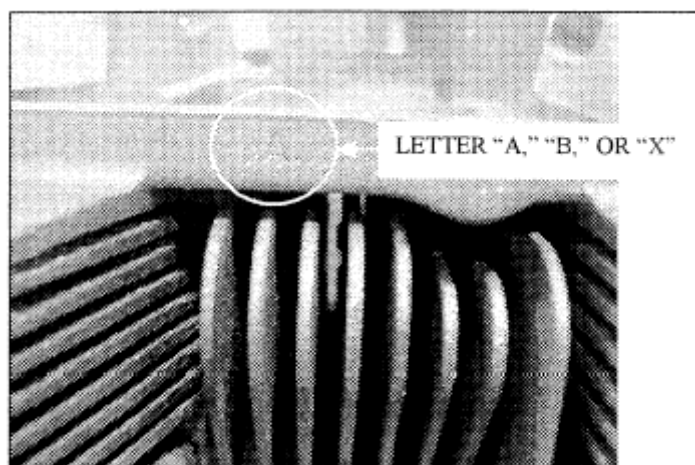
(ii) If there is a letter "A," "B," or "X" stamped on the flange of the rocker box, no further action is required. See Figure 4.

(iii) If there is no letter "A," "B," or "X" stamped on the flange of the rocker box, replace the cylinder before further flight.
