PŘÍKAZ K ZACHOVÁNÍ LETOVÉ ZPŮSOBILOSTI

Číslo: CAA-AD-T-039/2003

MD Helicopters, Inc.

VRTULNÍK – LISTY VYROVNÁVACÍHO ROTORU – KONTROLA/VÝMĚNA

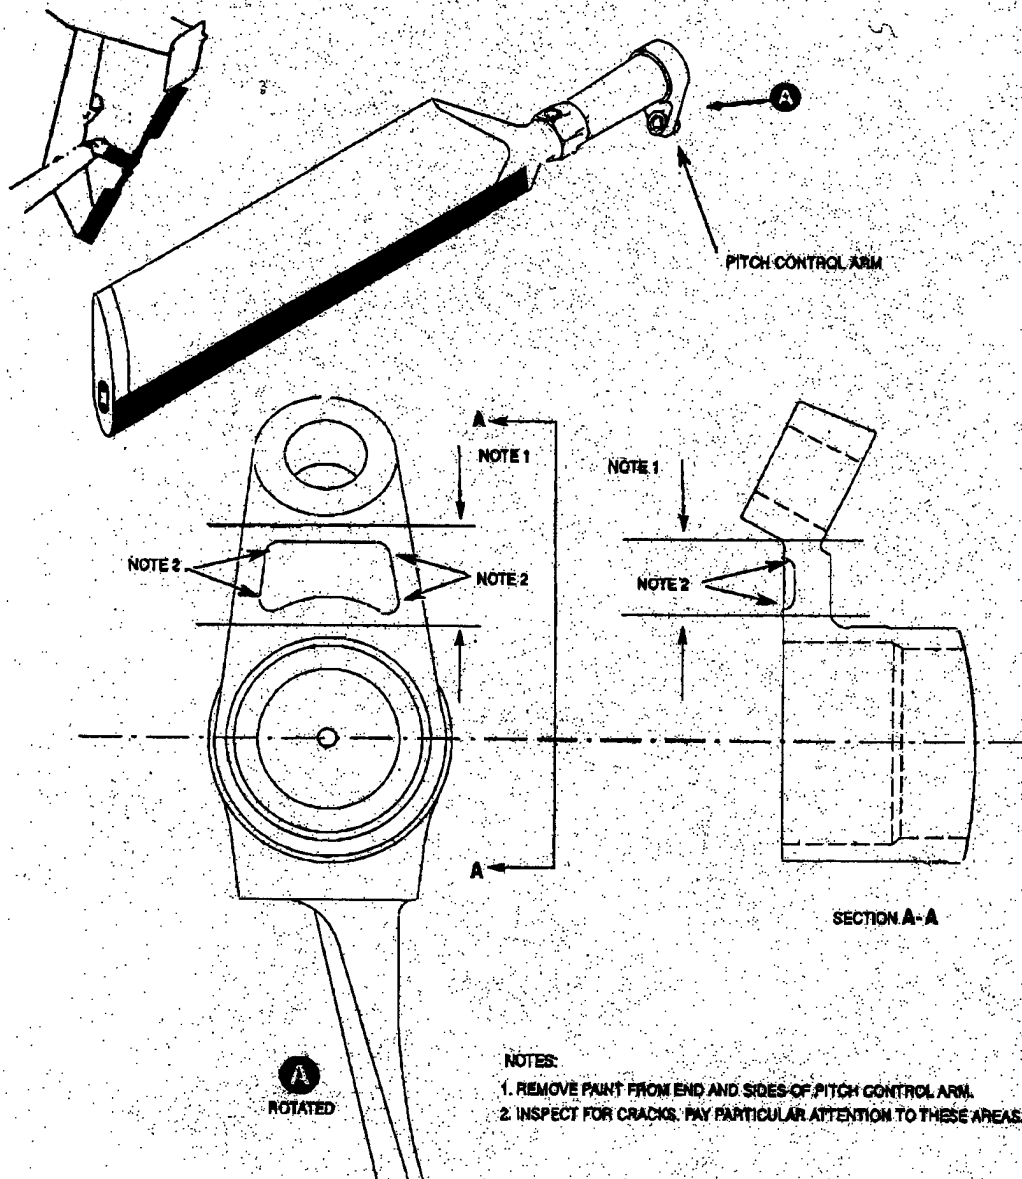
Figure 1. Tail Rotor Blade Assembly Inspection

To prevent a pitch horn from separating from the tail rotor blade leading to an unbalanced condition, vibration, loss of tail rotor pitch control, and loss of directional control of the helicopter, accomplish the following:

- (a) This AD establishes a new retirement life of 400 hours time-in-service (TIS) for the tail rotor blades listed in the Applicability section. For helicopters with an affected tail rotor blade installed that has 390 through 700 hours TIS, remove and replace the tail rotor blade with an airworthy tail rotor blade within 10 hours TIS.
- (b) Before further flight, perform a one-time visual inspection of each pitch horn for a crack or corrosion in the area indicated by Note 2 in Figure 1 of this AD. Paint removal in accordance with Note 1 of Figure 1 of this AD is not required for the visual inspection.

(d) For helicopters with a tail rotor blade installed that has more than 700 hours TIS, a one-time special flight permit to fly it to a repair facility may be issued only upon completion of an eddy current surface scan of each affected pitch horn (see Figure 1 of this AD). Paint removal in accordance with Note 1 of the Figure 1 of this AD **IS** required for the surface scan. If a crack is found, remove the tail rotor blade and replace it with an airworthy tail rotor blade before further flight.
