PŘÍKAZ K ZACHOVÁNÍ LETOVÉ ZPŮSOBILOSTI

Číslo: CAA-AD-T-039/2003 - oprava

VRTULNÍK – LISTY VYROVNÁVACÍHO ROTORU – KONTROLA/VÝMĚNA

2003-08-51 MD Helicopters, Inc.: Amendment 39-13215. Docket No. 2003-SW-17-AD.

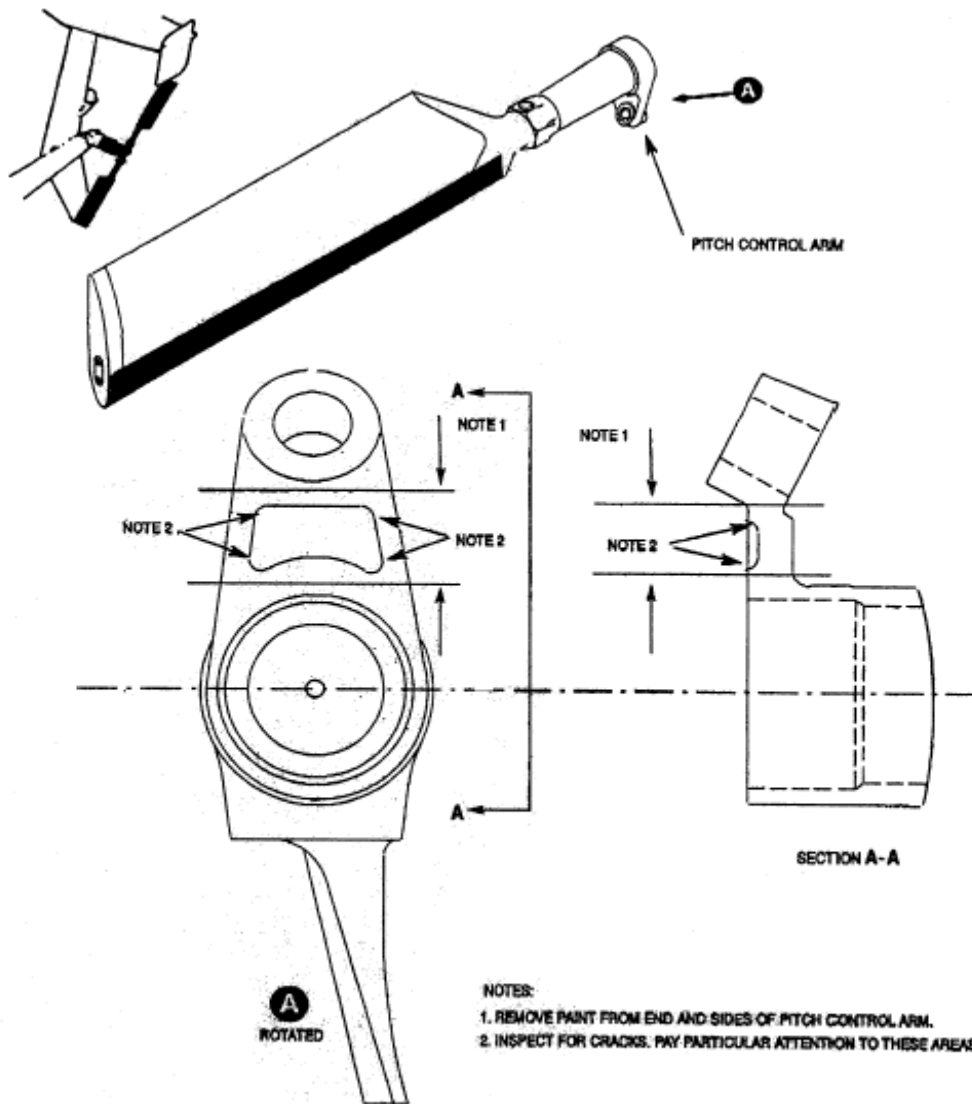
Figure 1. Tail Rotor Blade Assembly Inspection

To prevent a tail rotor blade pitch horn (pitch horn) from separating from the tail rotor blade, leading to an unbalanced condition, vibration, loss of tail rotor pitch control, and loss of directional control of the helicopter, accomplish the following:

(b) Before further flight, perform a one-time visual inspection of each pitch horn for a crack or corrosion in the area indicated by Note 2 in Figure 1 of this AD. Paint removal in accordance with Note 1 of Figure 1 of this AD is not required for the visual inspection.

(a) This airworthiness directive (AD) establishes a new retirement life of 400 hours time-in-service (TIS) for the tail rotor blades listed in the Applicability section. For helicopters with an affected tail rotor blade installed that has 390 through 700 hours TIS, remove and replace the tail rotor blade with an airworthy tail rotor blade within 10 hours TIS.

(d) For helicopters with a tail rotor blade installed that has more than 700 hours TIS, a one-time special flight permit to fly it to a repair facility may be issued only upon completion of an eddy current surface scan of each affected pitch horn (see Figure 1 of this AD). Paint removal in accordance with Note 1 of the Figure 1 of this AD IS required for the surface scan. If a crack is found, remove the tail rotor blade and replace it with an airworthy tail rotor blade before further flight.
