PŘÍKAZ K ZACHOVÁNÍ LETOVÉ ZPŮSOBILOSTI

CAA-AD-060/1999

LETADLO - ZÁVĚSY KŘÍDLA - KONTROLA

WINGS - FUSELAGE ATTACHMENT FITTINGS - INSPECTION

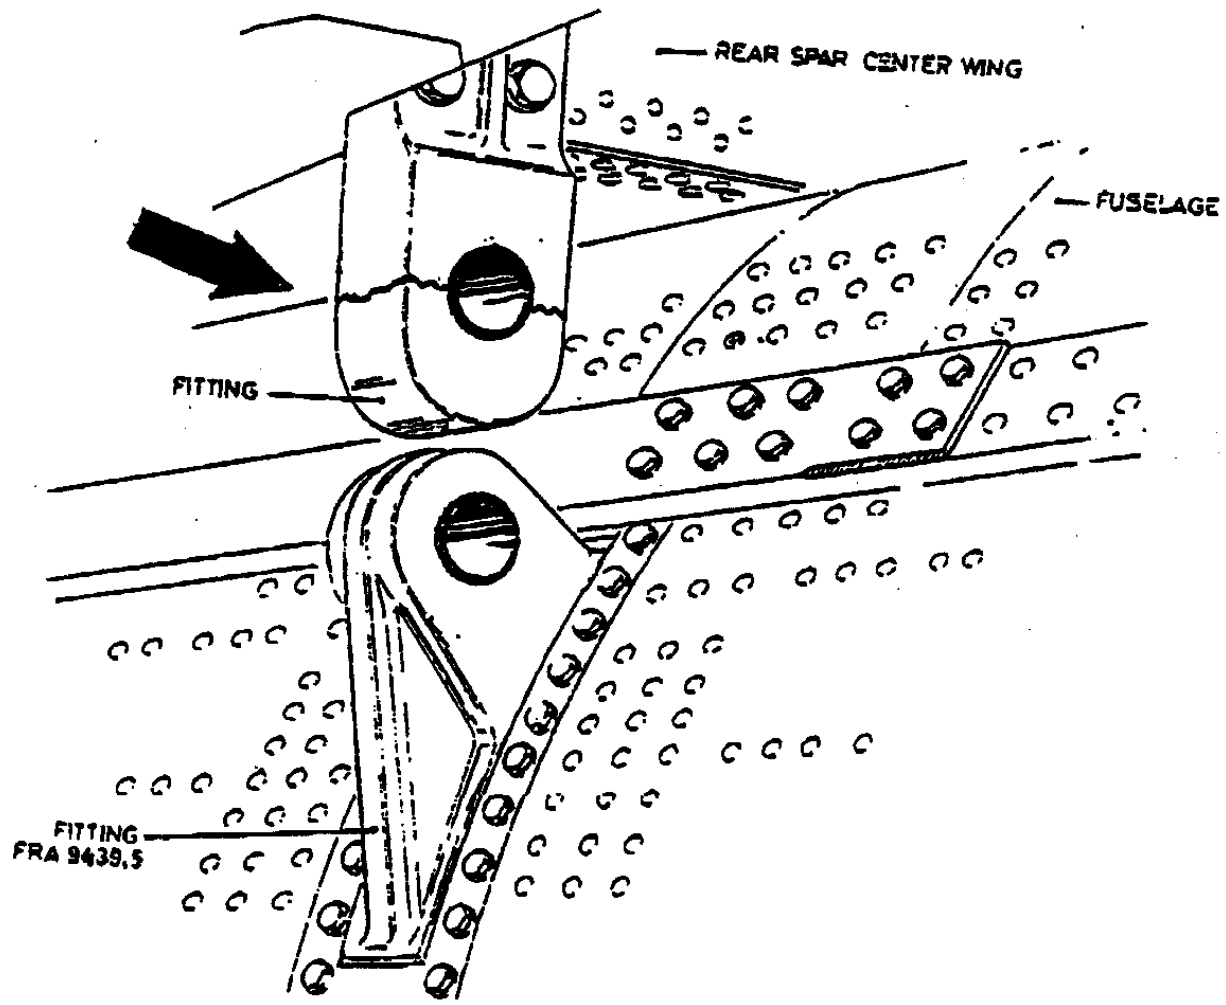
Recently, RLD have received a report from an F.27 "Friendship" operator concerning the discovery of a cracked wing-to-fuselage attachment fitting. There are four such fittings on the wing front- and rear spars, two on each spar on both sides of the fuselage. This particular fitting was located at Wing STA.1040, on the rear spar RH side. Subsequent investigation revealed that the cracking had resulted from stress corrosion. Subject fittings are manufactured from 7079-T6 aluminium, which is known to be sensitive to this type of corrosion. The affected aircraft had been inspected and modified in accordance with Fokker Service Bulletin (SB) F27/57-54 some eight (8) years prior to the cracked fitting being found.

Since an unsafe condition has been identified that may exist or develop on other aircraft of the same type design, this Airworthiness Directive (BLA) requires a one-time inspection of the affected wing-to-fuselage fittings (see Figure 1 of this directive) and the reporting of all findings to the present Type Certificate holder. RLD considers this directive to be a precautionary measure and further requirements may follow.

(a) Within the next 6 months after the effective date of this directive, inspect the wing-to-fuselage fittings in accordance with the Accomplishment Instructions of STORK Fokker SB F27/57-77 dated April 1, 1999 or a later RLD-approved revision;
