PŘÍKAZ K ZACHOVÁNÍ LETOVÉ ZPŮSOBILOSTI

Číslo: CAA-AD-065/2003

269A, 269A-1, 269B, 269C, TH-55A

VRTULNÍK - SILOVÝ UZEL PŘÍHRADOVÉ KONSTRUKCE DRAKU – KONTROLA/VÝMĚNA

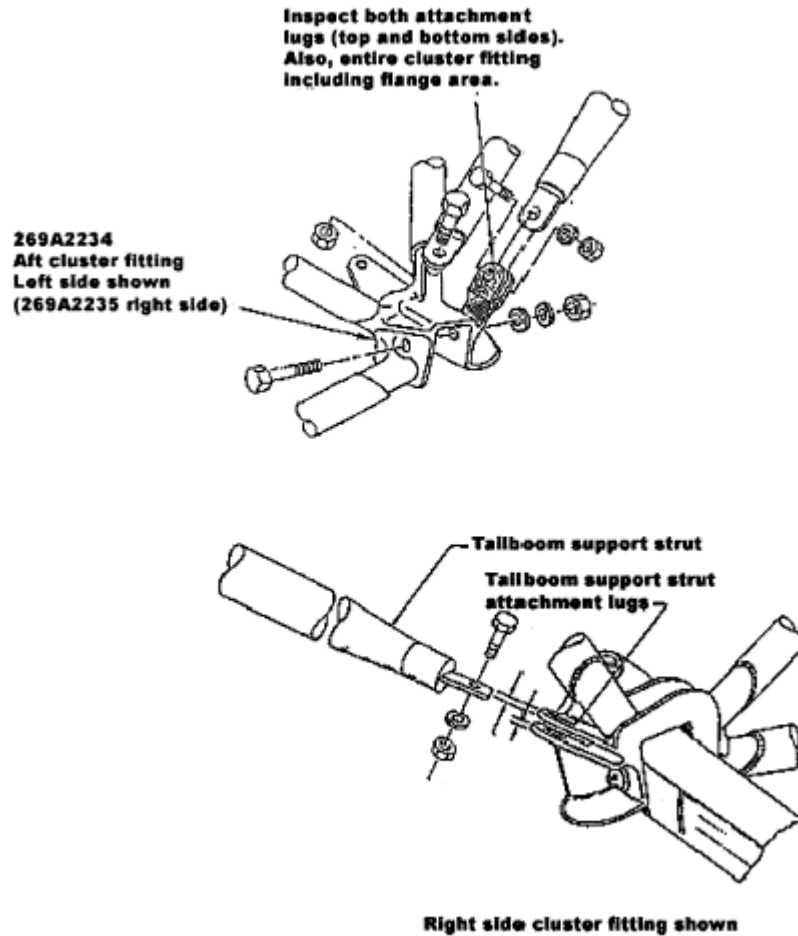
Figure 1

To prevent failure of a tailboom support strut or lug on a cluster fitting, which could cause rotation of a tailboom into the main rotor blades, and subsequent loss of control of the helicopter, accomplish the following:

(2) Dye-penetrant inspect the lugs on each cluster fitting. See the following Figure 1:

(3) If a crack is found, before further flight, replace the cracked cluster fitting with an airworthy cluster fitting.
