## PŘÍKAZ K ZACHOVÁNÍ LETOVÉ ZPŮSOBILOSTI

Číslo: CAA-AD-065/2003R1

Schweizer Aircraft Corp.

### VRTULNÍK - SILOVÝ UZEL PŘÍHRADOVÉ KONSTRUKCE DRAKU – KONTROLA/VÝMĚNA

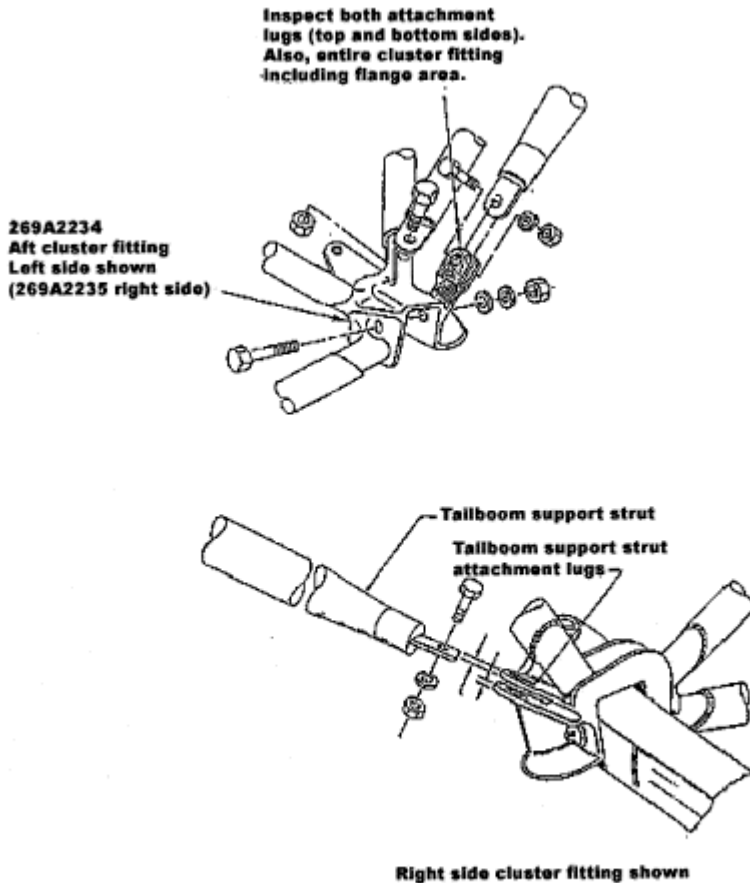
Figure 1

To prevent failure of a tailboom support strut or lug on a cluster fitting, which could cause rotation of a tailboom into the main rotor blades, and subsequent loss of control of the helicopter, accomplish the following:

(2) Dye-penetrant inspect the lugs on each cluster fitting. See the following Figure 1:

(3) If a crack is found, before further flight, replace the cracked cluster fitting with an airworthy cluster fitting.
