AIRWORTHINESS DIRECTIVE

Number: CAA-AD-065/2003R1

Schweizer Aircraft Corp.

HELICOPTER – CLUSTER FITTING – INSPECTION/REPLACEMENT

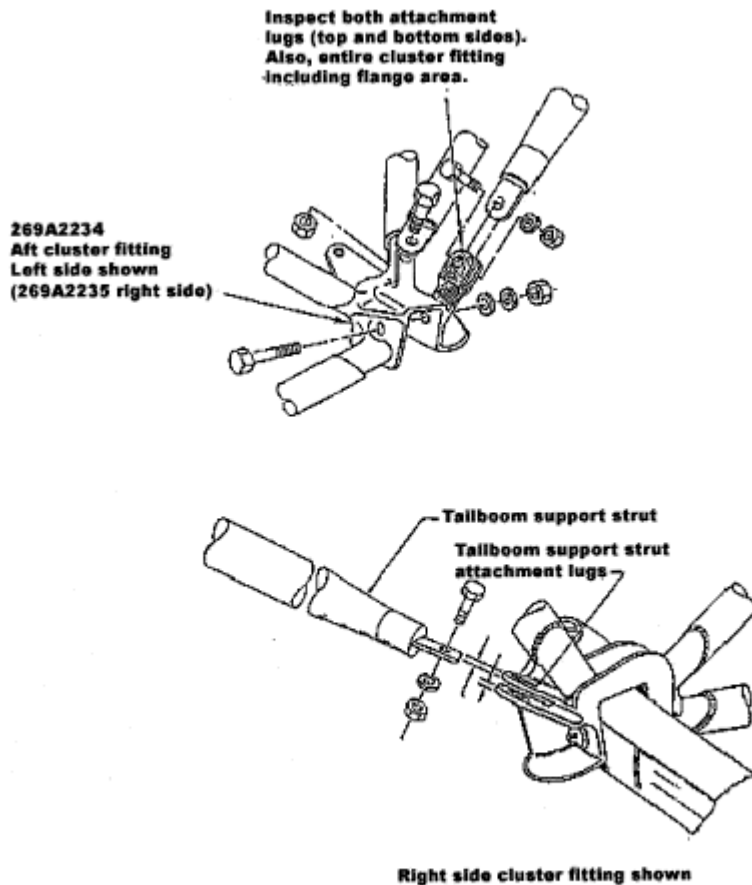
Figure 1

To prevent failure of a tailboom support strut or lug on a cluster fitting, which could cause rotation of a tailboom into the main rotor blades, and subsequent loss of control of the helicopter, accomplish the following:

- (1) Using paint remover, remove paint from the lugs on each cluster fitting. Wash with water and dry. The tailboom support strut must be removed prior to the paint stripping.
- (2) Dye-penetrant inspect the lugs on each cluster fitting. See the following Figure 1:

(3) If a crack is found, before further flight, replace the cracked cluster fitting with an airworthy cluster fitting.
