PŘÍKAZ K ZACHOVÁNÍ LETOVÉ ZPŮSOBILOSTI

Číslo: CAA-AD-085/2004

LETADLOVÉ ZAŘÍZENÍ - OHŘÍVAČ VODY - KONTROLA

DGAC AD No.: F-2004-132

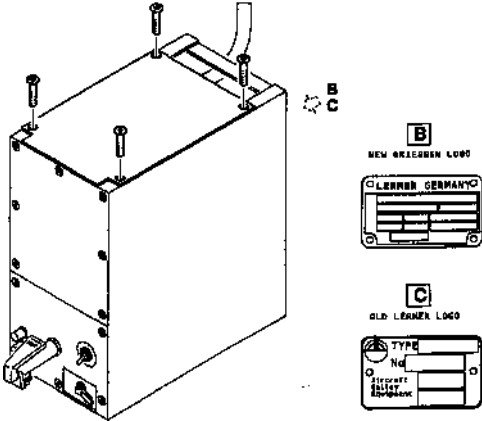
Figure 1

i. If the new DRIESSEN logo exists (see fig 1), no further action is required. Go to step C of this procedure.
