AIRWORTHINESS DIRECTIVE

Number: CAA-AD-085/2004

LERMER GmbH

APPLIANCE - WATER HEATER - INSPECTION

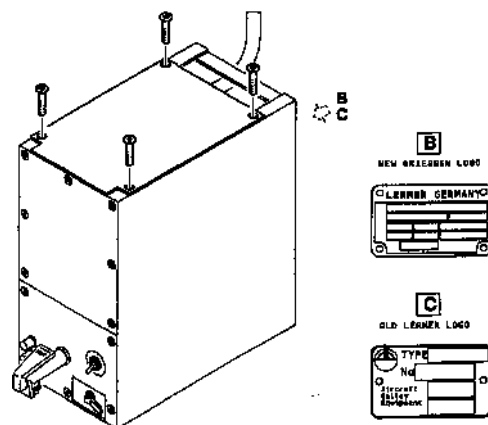
Figure 1

i. If the new DRIESSEN logo exists (see fig 1), no further action is required. Go to step C of this procedure.
