PŘÍKAZ K ZACHOVÁNÍ LETOVÉ ZPŮSOBILOSTI

Číslo: CAA-AD-T-093/2003

ROBINSON HELICOPTER COMP.
R44, R44 II

VRTULNÍK – HLAVNÍ A VYROVNÁVACÍ ROTOR – JISTÍCÍ ŠROUBY – KONTROLA/VÝMĚNA

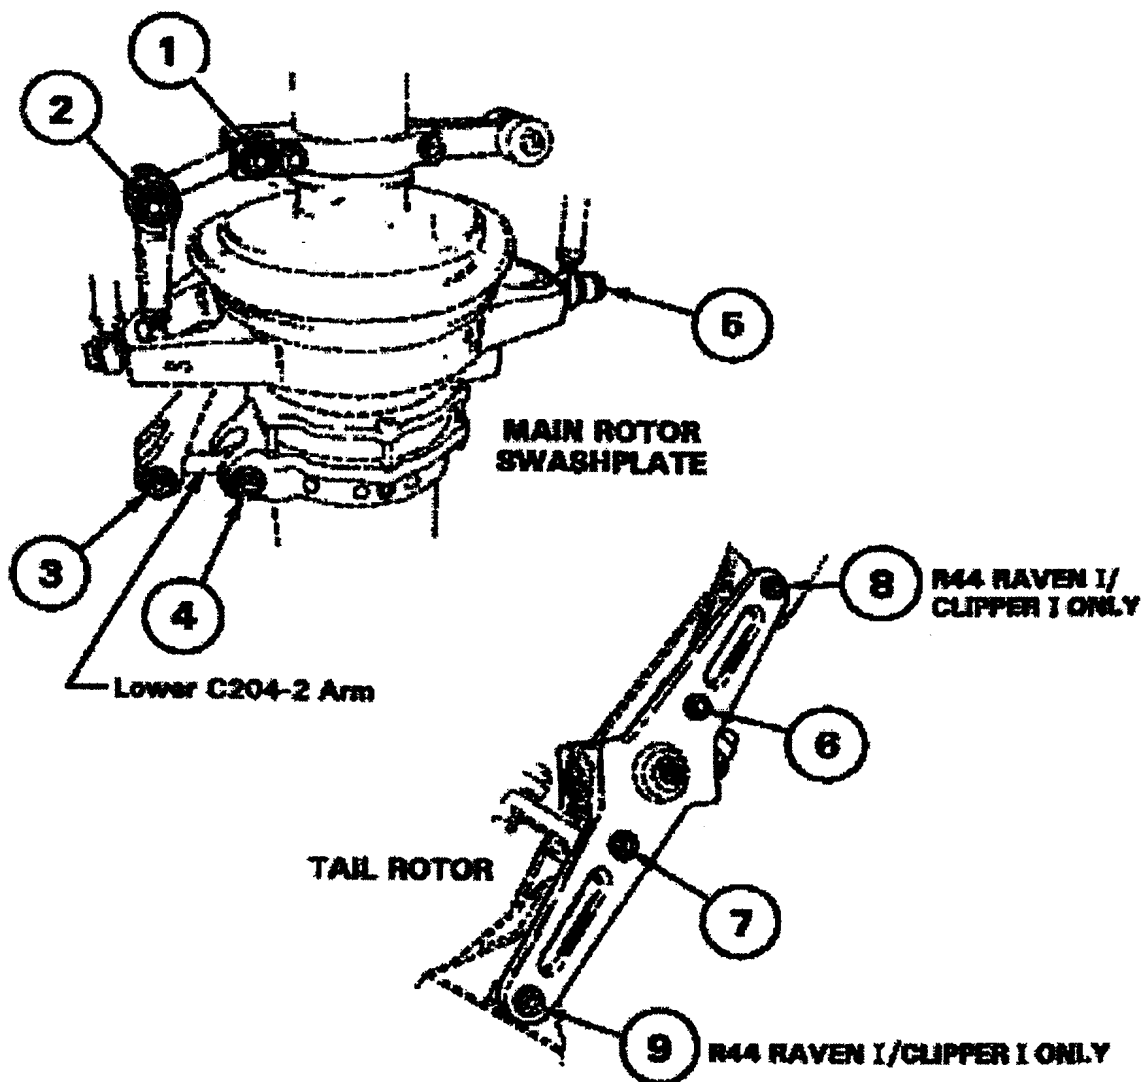
in Figure 1 of this AD, and determine if any bolt, part number (P/N) NAS6605-31, shown in Figure 1

(1) Visually inspect each bolt for fretting residue under the bolt head, which indicates a loose, potentially cracked bolt.

(2) Apply 10-15 ft-lb (13-20 Nm) torque to each bolt head and verify no rotation. See Figure 1 of this AD.

Suspect NAS6605-31 Bolts

9 Place on R44

7 Places on R44 II

(3) If residue or rotation of the bolt is found, before further flight, replace each unairworthy bolt with an airworthy bolt that does not have a vendor identification marking of 01DO.

or by December 31, 2003, whichever occurs first, replace each bolt, P/N NAS6605-31, that has vendor identification marking 01DO on the bolt head, with an airworthy bolt, P/N NAS6605-31,
