PŘÍKAZ K ZACHOVÁNÍ LETOVÉ ZPŮSOBILOSTI

Číslo: CAA-AD-1-025/98

KLUZÁK - RYCHLOSPOJKY ŘÍZENÍ - ÚPRAVA

**Airworthiness
Directive
1994-001/2**

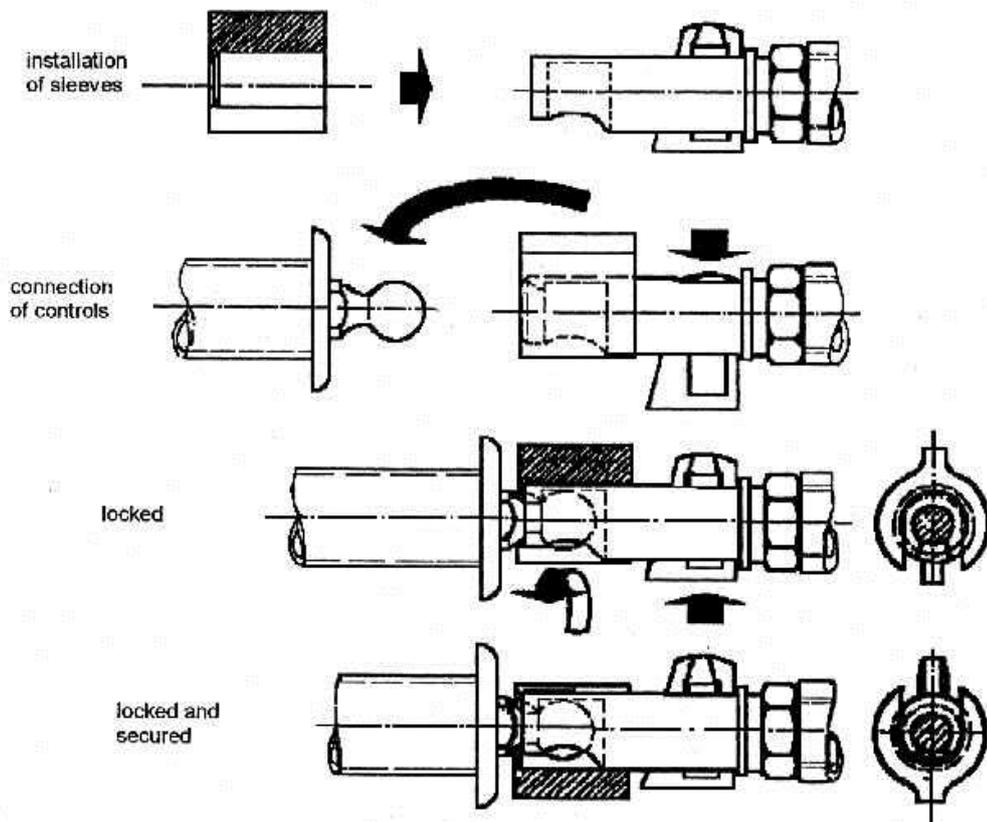
Section III

They may by no means be clipped radially onto the L'Hotellier ball and socket connector. Radial clipping (excessive opening of the sleeve) may lead to cracks or ruptures due to oversteering so that the sleeve cannot function properly any more.

For installation, the sleeves have to be slid axially onto the L'Hotellier ball and socket connectors.

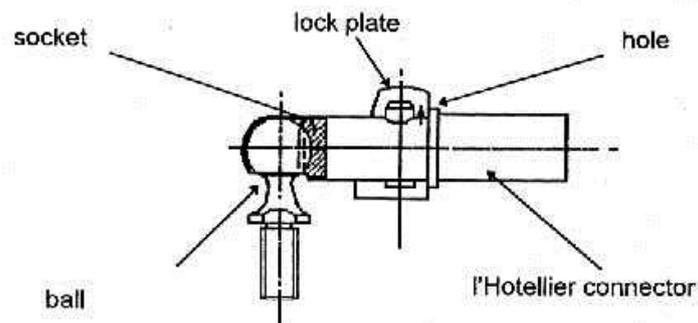
Section I

Unsecured ball and socket connectors may open automatically in flight!

If the connectors are not yet equipped with safety pins (e.g. l'H 140-31 made by Hotellier), these safety pins have to be retrofitted. In certain cases it may become necessary to rebores the hole in the lock plate, which is provided for visual inspection, to $\varnothing 1.2$ mm so that the safety pin can be inserted.

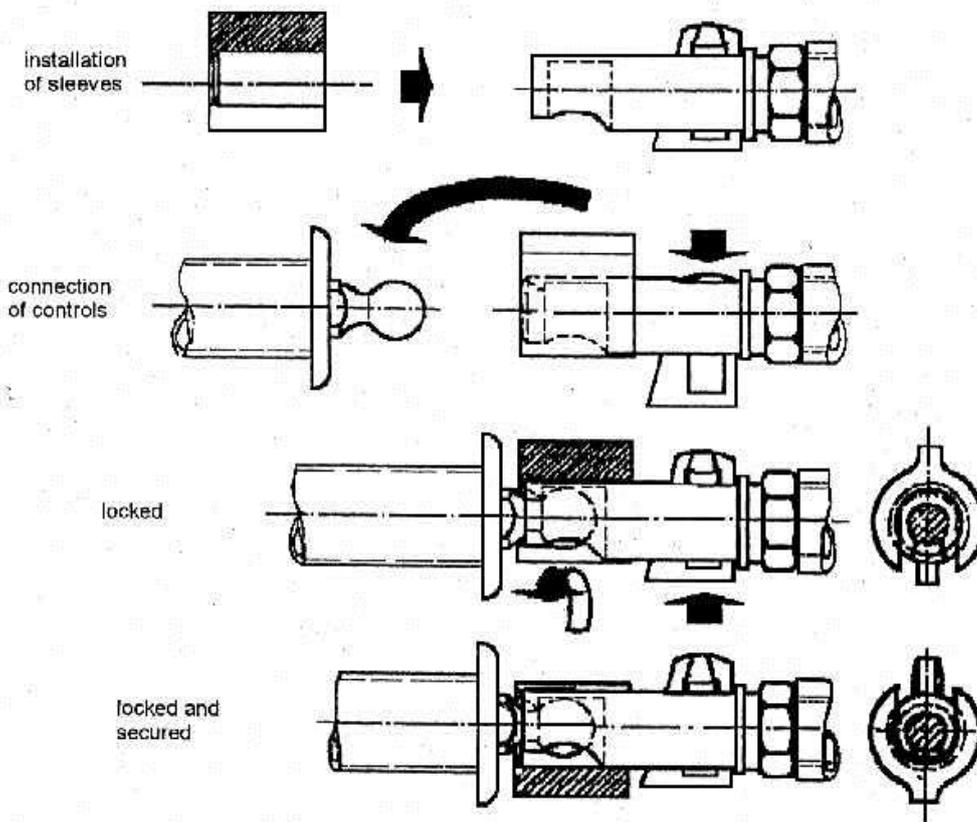
Section III

They may by no means be clipped radially onto the l'Hotellier ball and socket connector. Radial clipping (excessive opening of the sleeve) may lead to cracks or ruptures due to overstressing so that the sleeve cannot function properly any more.

For installation, the sleeves have to be slid axially onto the l'Hotellier ball and socket connectors.

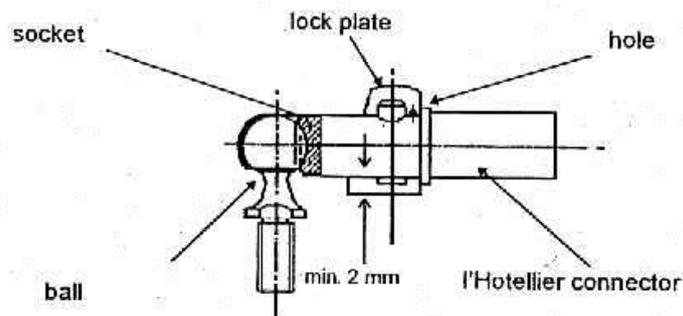
Section IV

Unsecured ball and socket connectors may open automatically in flight.

The socket is to be slid completely over the ball with the lock plate pressed down. During locking the lock plate moves back slightly so that in a correct connection the hole on the narrow edge of the lock plate becomes visible.

The safety pin is to be inserted in this hole thus securing the ball and socket connector.

By loading the connection full engagement of the ball is to be verified!
