## AIRWORTHINESS DIRECTIVE

**Number:** CAA-AD-1-025/98

### SAILPLANE - L'HOTELLIER BALL AND SOCKET CONNECTORS

**Airworthiness  
Directive  
1994-001/2**

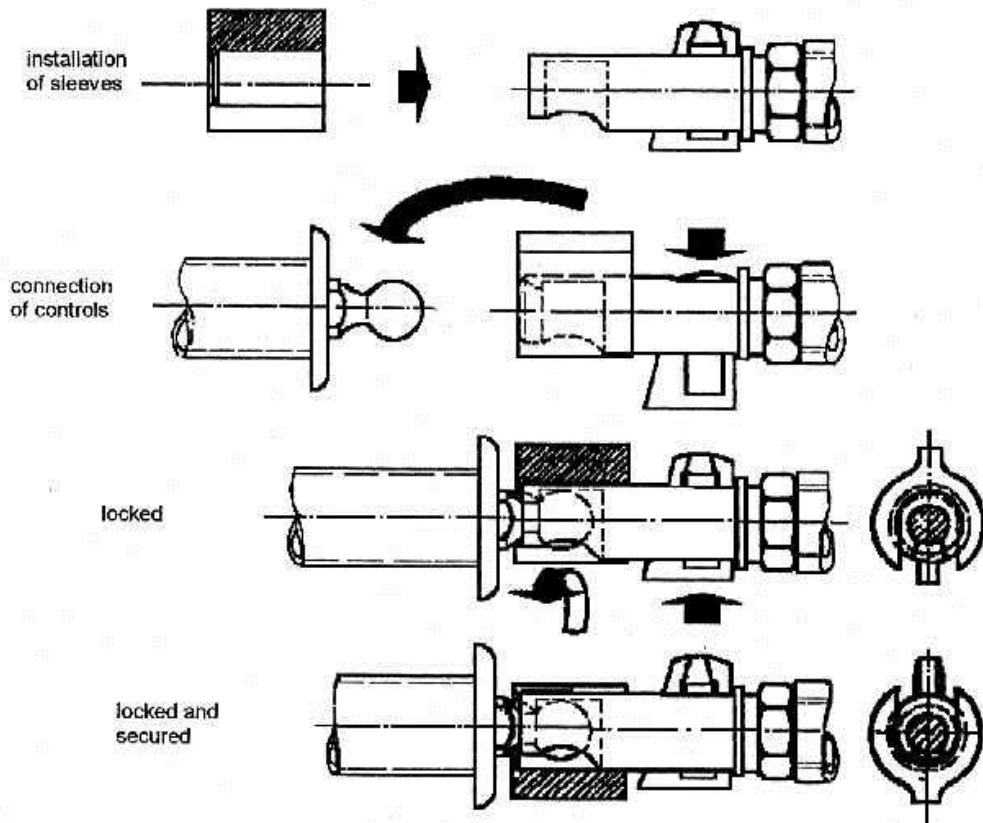
They may by no means be clipped radially onto the L'Hotellier ball and socket connector. Radial clipping (excessive opening of the sleeve) may lead to cracks or ruptures due to oversteering so that the sleeve cannot function properly any more.

For installation, the sleeves have to be slid axially onto the L'Hotellier ball and socket connectors.

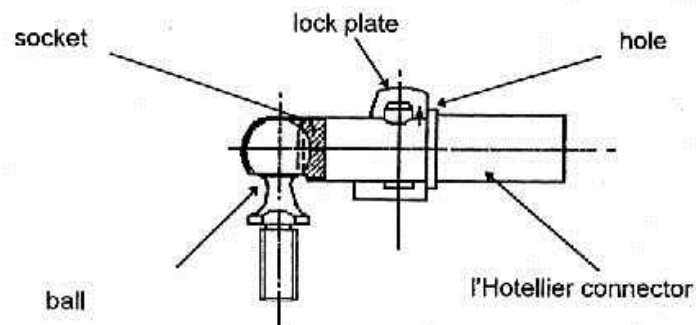
**Unsecured ball and socket connectors may open automatically in flight!**

If the connectors are not yet equipped with safety pins (e.g. l'H 140-31 made by Hotellier), these safety pins have to be retrofitted. In certain cases it may become necessary to rebores the hole in the lock plate, which is provided for visual inspection, to  $\varnothing 1.2$  mm so that the safety pin can be inserted.

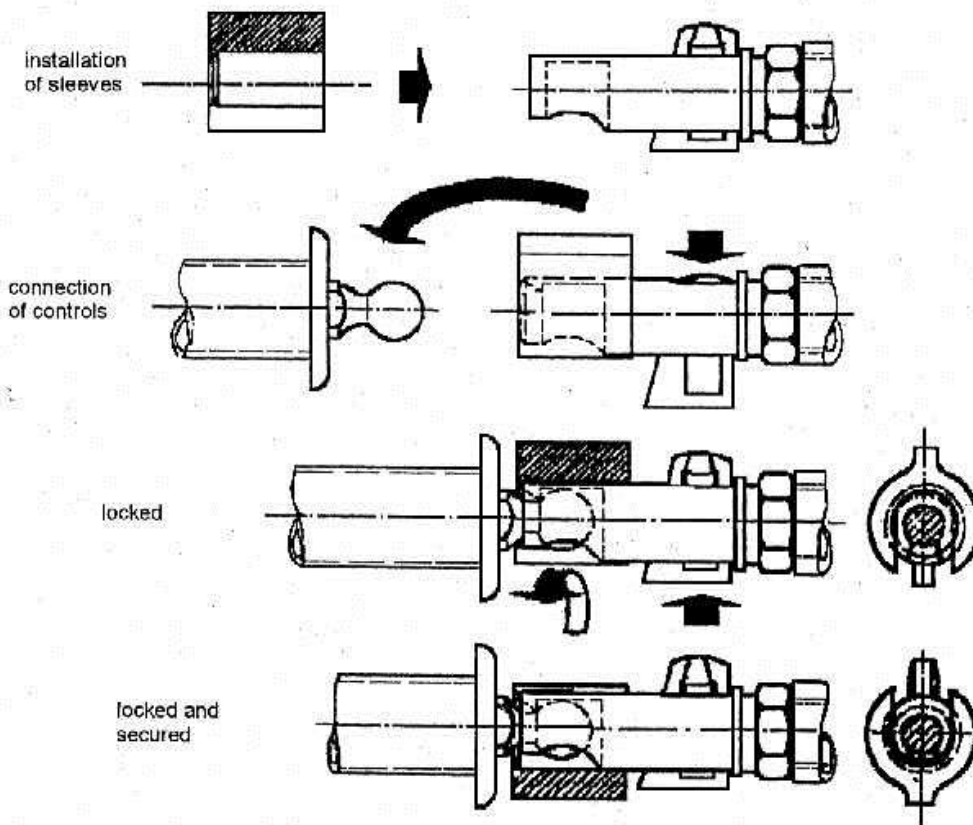
They may by no means be clipped radially onto the l'Hotellier ball and socket connector. Radial clipping (excessive opening of the sleeve) may lead to cracks or ruptures due to overstressing so that the sleeve cannot function properly any more.

For installation, the sleeves have to be slid axially onto the l'Hotellier ball and socket connectors.

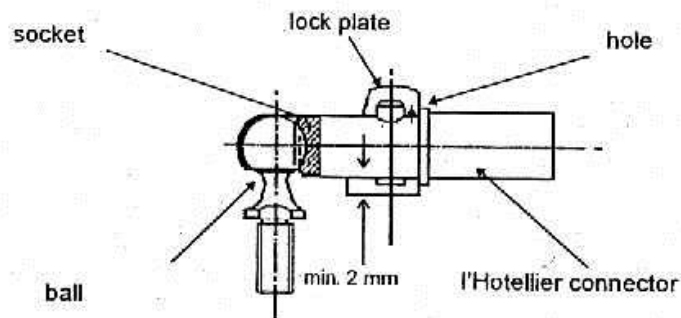
Unsecured ball and socket connectors may open automatically in flight.

The socket is to be slid completely over the ball with the lock plate pressed down. During locking the lock plate moves back slightly so that in a correct connection the hole on the narrow edge of the lock plate becomes visible.

The safety pin is to be inserted in this hole thus securing the ball and socket connector.

By loading the connection full engagement of the ball is to be verified!
