## PŘÍKAZ K ZACHOVÁNÍ LETOVÉ ZPŮSOBILOSTI

**Číslo: 2005-16-05**

**Robinson Helicopter Company**  
vrtulník model R-22

#### **Airworthiness Directives; Robinson Helicopter Company Model R-22 Series Helicopters**

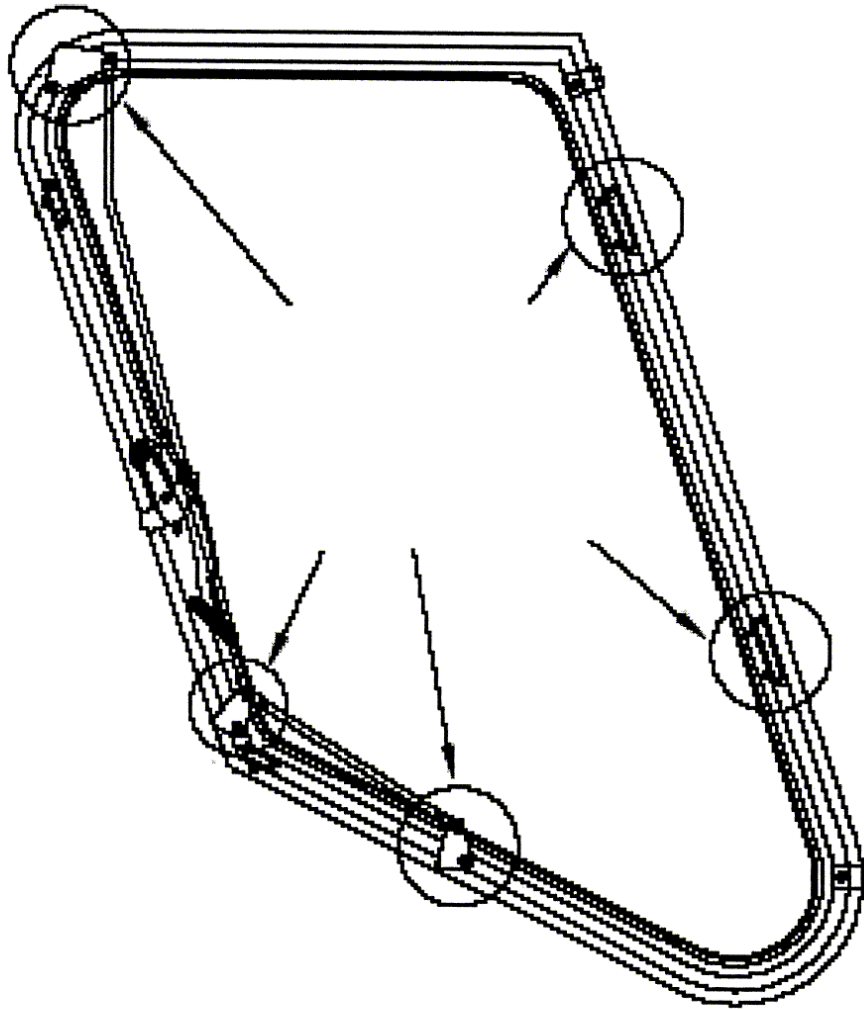
**Figure 1**

(1) Visually inspect each pilot and copilot door assembly integral frame for a crack in the locations depicted in Figure 1 of this AD. If a crack is found, before further flight, replace the cracked door assembly, part number (P/N) R-22-101-51 or P/N R-22-101-53 (left-hand door assembly), or P/N R-22-101-52 or P/N R-22-101-54 (right-hand door assembly), with an airworthy door assembly. If you use door assembly, P/N R-22-101-51 or P/N R-22-101-53 (left-hand door assembly), or P/N R-22-101-52 or P/N R-22-101-54 (right-hand door assembly) as the replacement, then install it in accordance with Tech-Tool Plastics, Inc. Installation Instructions TTP-1R, Revision A, dated November 21, 1997, and with the sections titled "Door Weather Seal Installation" and "Cotter Pin Installation" in Tech-Tool Plastics, Inc. Service Bulletin No. TTP2005-01, Revision A, dated February 1, 2005 (SB).

**Door Assembly (left-hand shown) View Looking Outboard**

(b) After accomplishing the inspections in paragraphs (a) through (a)(2)(ii) of this AD, at intervals not to exceed 100 hours time-in-service, visually inspect each pilot and copilot door assembly integral frame for a crack in the locations depicted in Figure 1 of this AD.

(c) If a crack is found, before further flight, replace the cracked door assembly, P/N R-22-101-51 or P/N R-22-101-53 (left-hand door assembly), or P/N R-22-101-52 or P/N R-22-101-54 (right-hand door assembly), with an airworthy door assembly. If the replacement door assembly is P/N R-22-101-51 or P/N R-22-101-53 (left-hand door assembly), or P/N R-22-101-52 or P/N R-22-101-54 (right-hand door assembly), then install it in accordance with Tech-Tool Plastics, Inc. Installation Instructions TTP-1R, Revision A, dated November 21, 1997, and "Door Weather Seal Installation" and "Cotter Pin Installation" sections of the SB.
