**Číslo: 2005-20-11**

**Rolls-Royce Corporation**  
modely 250-C28, -C28B, -C28C

**[Docket No. FAA-2005-22534; Directorate Identifier 2005-NE-27-AD; Amendment 39-14305; AD 2005-20-11]**

#### **Airworthiness Directives; Rolls-Royce Corporation (RRC) (formerly Allison Engine Company, Allison Gas Turbine Division, and Detroit Diesel Allison) Models 250-C28, -C28B, and -C28C Turboshaft Engines**

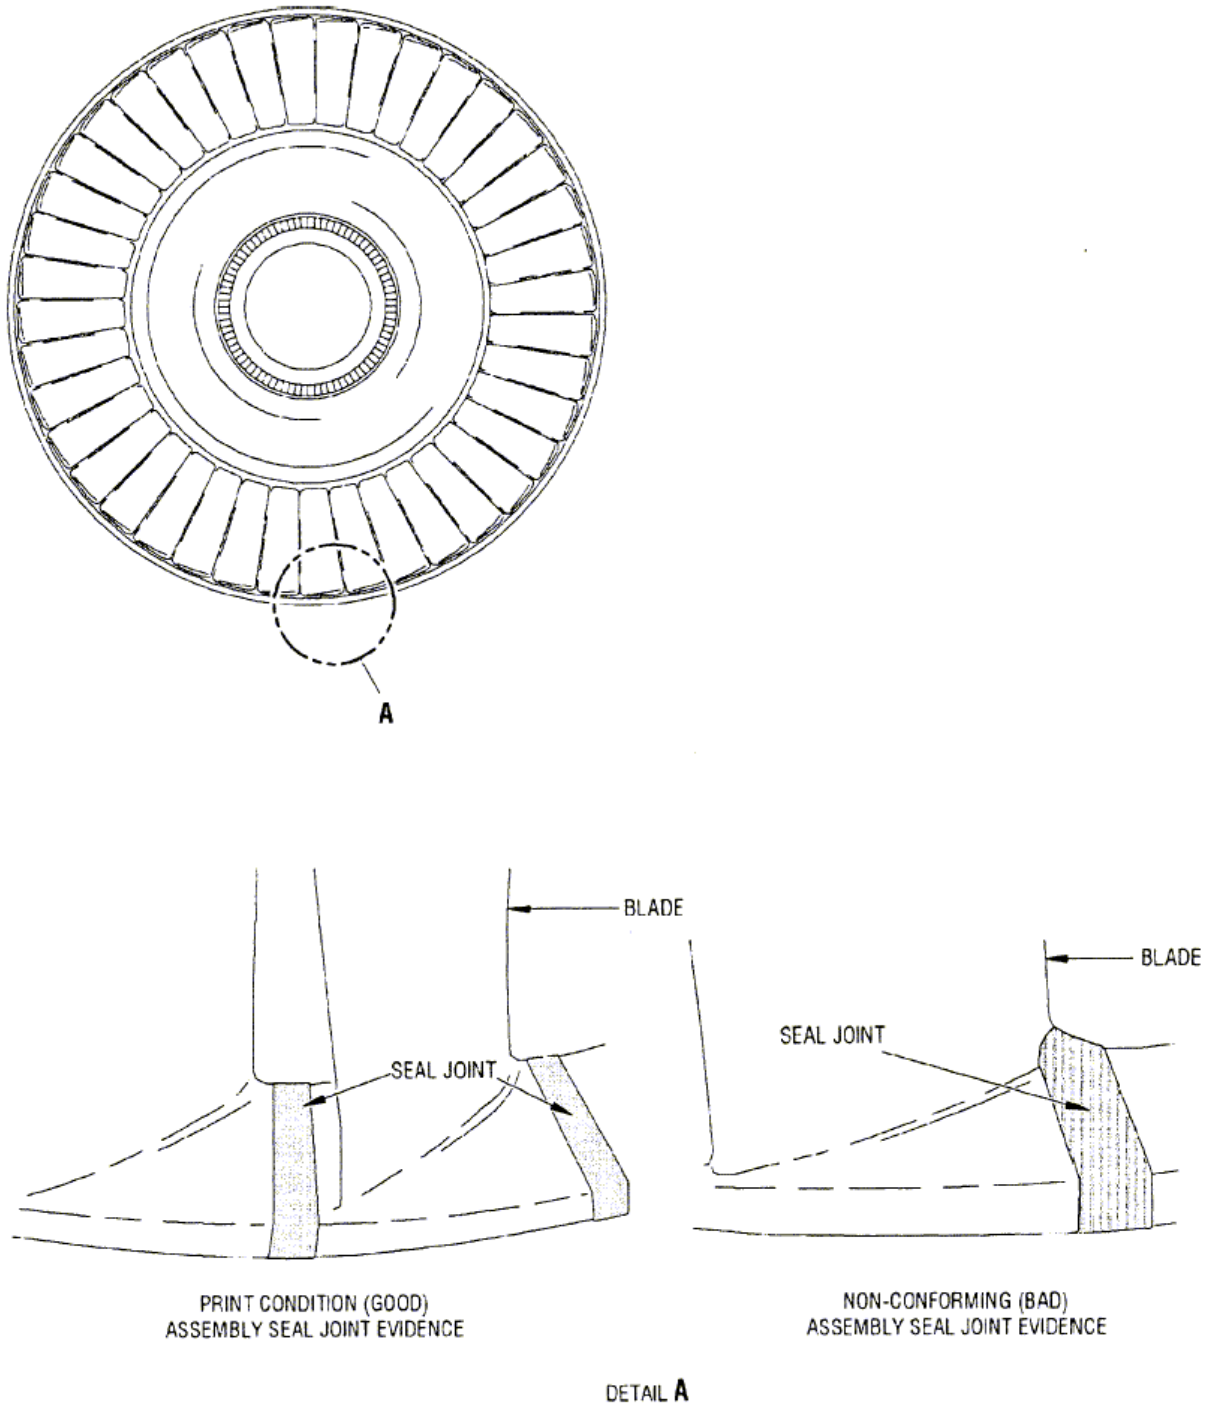
Figure 1.

**SUPPLEMENTARY INFORMATION:** In April 2005, we became aware of reports of three failed third-stage turbine wheels, P/N 6899383. The third-stage turbine wheels had partial loss of the blades and shroud. RRC conducted an analysis and found the failures were caused by compromised third-stage blade fillet radii, which led to increased stresses to the third-stage blades and shroud. RRC categorized this finding as a manufacturer's quality control problem. This condition, if not corrected, could result in loss of power and uncommanded engine shutdown due to failure of the third-stage turbine wheel.

(h) Remove the third-stage turbine wheel and perform a onetime visual inspection of the seal joint in each passage between airfoils at the hub and shroud. Seal joint evidence must not be present within blade fillet radii. See Figure 1 of this AD for reference.

(i) Remove from service any turbine wheel that has seal joint evidence present within blade fillet radii.
