PŘÍKAZ K ZACHOVÁNÍ LETOVÉ ZPŮSOBILOSTI

Číslo: 2007-05-14

General Electric Company (GE)
motor CF6-80C2

Airworthiness Directives; General Electric Company (GE) CF6-80C2 Turbofan Engines

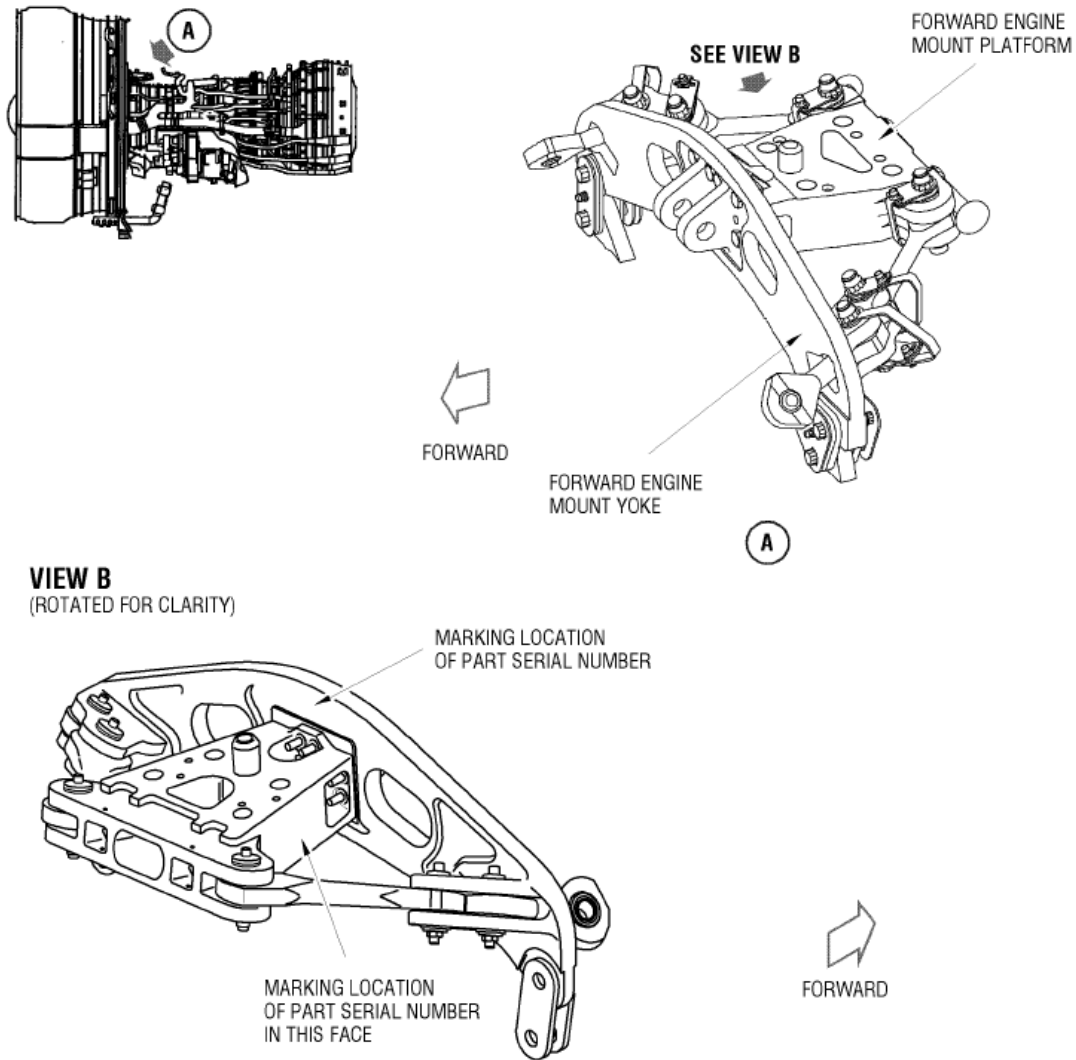
Location of Forward Engine Mount Platform and Forward Engine Mount Yoke
Figure 1

(d) This AD results from the discovery of cracks in a forward engine mount platform and a forward engine mount yoke found during fluorescent penetrant inspection (FPI). We are issuing this AD to prevent cracks in the forward engine mount platform and forward engine mount yoke that could result in possible separation of the engine from the airplane.

(p) Location of the forward engine mount platform and forward engine mount yoke and SN are illustrated in the following Figure 1.

(n) Replace the affected forward engine mount platform and or the affected forward engine mount yoke with a non-weld-repaired cast titanium forward engine mount platform and or the forward engine mount yoke or a forged titanium forward engine mount platform or a forged titanium forward engine mount yoke.
