PŘÍKAZ K ZACHOVÁNÍ LETOVÉ ZPŮSOBILOSTI

Číslo: 2008-0137-E

ATR-GIE Avions de Transport Régional
ATR72

EASA	EMERGENCY AIRWORTHINESS DIRECTIVE

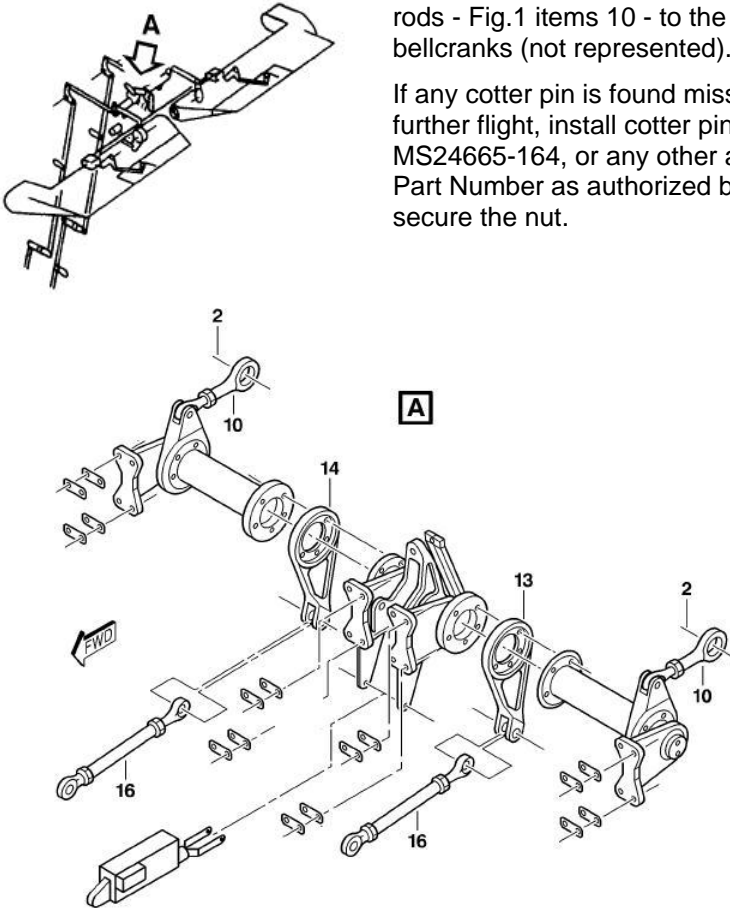
<p>Reason: Incomplete accomplishment instructions in SB ATR72-27-1059 original issue and Revision 1, failed to mention installation of cotter pins to secure the self locking nuts after re-installation of the modified Pitch Uncoupling Mechanism (PUM), when connecting the elevator control linkage rods to the PUM input levers and the PUM output rods to the elevator bellcranks (on both sides).</p> <p>Because of the non-installation of these four cotter pins, the fail-safe criteria of the design requirements on the pitch control are no longer met. Such a failure could cause the loss of one self locking nut and would result in the loss of pitch control on one side - Captain or First Officer - or the loss of control of one elevator surface. The symmetrical loss of two concerned self-locking nuts could lead to a complete loss of the pitch</p>

<p>control.</p> <p>For the reasons stated above, this AD requires you to check the presence of the four cotter pins and their installation if they are found to be missing.</p>
<p>Effective Date:</p>	<p>25 July 2008</p>
<p>Required action(s) and Compliance Time(s):</p>	<p>Required as indicated, unless previously accomplished.</p> <p>(1) Within 10 days after the effective date of this AD, verify the installation of the four cotter pins securing the nuts of the fastener assemblies connecting the elevator control rods - Fig.1 items 16 - to the PUM input levers - Fig.1 item 13 and 14 - and the PUM output rods - Fig.1 items 10 - to the elevator bellcranks (not represented).</p>

<p>If any cotter pin is found missing, before further flight, install cotter pin P/N MS24665-164, or any other alternative Part Number as authorized by ATR to secure the nut.</p> <p>Figure 1</p> <p>NOTE: For accessing the zone to be inspected, panels 325BL, 325BR, 327HL, 327KL, 327KR, 327JR, 327 JL, 333BB, 334BB may need to be removed per AMM 06-41-30.</p> <p>(2) After accomplishment of paragraph (1) of this AD; before further flight, perform an operational test of the elevator control in accordance with the current revision of ATR 72 Job Instruction Card (JIC) 27-30-00 OPT 10000, OPERATIONAL TEST OF ELEVATOR CONTROL AND TABS.</p> <p>All actions for accomplishing the requirements of this AD must be done in accordance with current applicable service instructions published by ATR, and if during the inspection and corrective actions required by this AD, any damage to airplanes that is found and that is not covered in any of the ATR 72 service publications, thus prohibiting the release of the airplane in a serviceable condition, contact ATR to obtain the procedure in order to restore the aircraft to an approved configuration and implement the procedure accordingly.</p>
