PŘÍKAZ K ZACHOVÁNÍ LETOVÉ ZPŮSOBILOSTI

Číslo: 2008-03-09

CFM International
CFM56-7B

Airworthiness Directives; CFM International, S.A. CFM56-7B Series Turbofan Engines

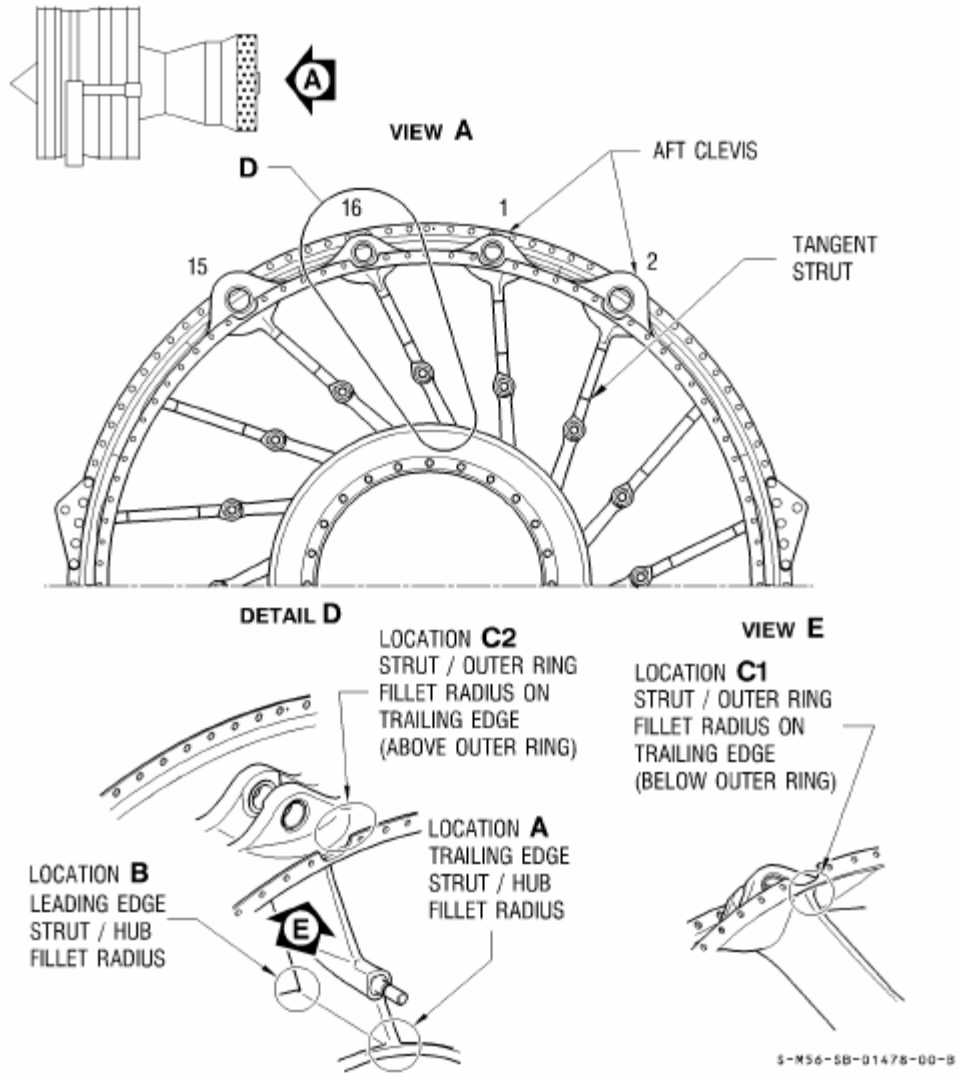
Figure 805

(d) This AD results from a refined lifing analysis by the engine manufacturer that shows the need to identify an initial threshold for inspecting certain TRFs. We are issuing this AD to prevent failure of the TRF from low-cycle fatigue cracks. Failure of the TRF could result in engine separation from the airplane, which could lead to loss of control of the airplane.

2. Mandatory Inspection Intervals for the Critical Areas of the Turbine Rear Frame with Tangential Struts (4 Mount Struts, No. 1, 2, 15, and 16).
 - C. Turbine Rear Frame Part Numbers 340-166-205-0, 340-166-206-0, 340-166-207-0, 340-166-208-0, 340-166-209-0, 340-166-210-0, for all CFM56-7B SAC engine models (except -7B27A engine models). Refer to figure 805.

Figure Index No.	Inspection Location	Inspection Threshold (Cycles since new)	Inspection Intervals (Cycles)	Inspection Reference
805	Strut/outer ring fillet radius on trailing edge (A)	25,000* for -7B SAC (except business jet) engine models	Refer to Figure 806* for -7B SAC (except business jet) engine models	Refer to SB 72-0579*
	Strut/hub fillet radius on leading edge (B)	19,000* for -7B SAC business jet engine models	Refer to Figure 807* for -7B SAC business jet engine models	
	Strut/outer ring fillet radius on trailing edge (C1 below outer ring)			
	Strut/outer ring fillet radius on trailing edge (C2 above outer ring)

Turbine Rear Frame with Tangential Struts P/N 340-166-205-0,
340-166-206-0, 340-166-207-0, 340-166-208-0, 340-166-209-0, 340-166-210-0 – Areas to Be
Inspected

If no crack is found on any of the four mount struts, the turbine rear frame is serviceable and must be re-inspected at 4,700 cycle repetitive intervals. If cracks are found on the mount struts, the TRF must be re-inspected according to the following repetitive intervals:

TOTAL CUMULATED CRACK LENGTH AT EACH LOCATION	RE-INSPECT WITHIN
$L < 0.20$ (5)	4,700
$0.20 (5) \leq L < 0.28$ (7)	3,300
$0.28 (7) \leq L < 0.39$ (10)	1,300
$0.39 (10) \leq L < 0.59$ (15)	700
$0.59 (15) \leq L < 0.79$ (20)	120
$L \geq 0.79$ (20)	IMMEDIATELY REMOVE THE TURBINE FRAME

If no crack is found on any of the four mount struts, the turbine rear frame is serviceable and must be re-inspected at 3,300 cycle repetitive intervals. If cracks are found on the mount struts, the TRF must be re-inspected according to the following repetitive intervals:

TOTAL CUMULATED CRACK LENGTH AT EACH LOCATION	RE-INSPECT WITHIN
$L < 0.20$ (5)	3,300
$0.20 (5) \leq L < 0.28$ (7)	2,400
$0.28 (7) \leq L < 0.39$ (10)	900
$0.39 (10) \leq L < 0.59$ (15)	500
$0.59 (15) \leq L < 0.79$ (20)	80
$L \geq 0.79$ (20)	IMMEDIATELY REMOVE THE TURBINE FRAME
