**[Docket No. FAA-2007-27229; Directorate Identifier 2007-NE-03-AD; Amendment 39-15359; AD 2008-03-09]**

#### **Airworthiness Directives; CFM International, S.A. CFM56-7B Series Turbofan Engines**

**ACTION:** Final rule.

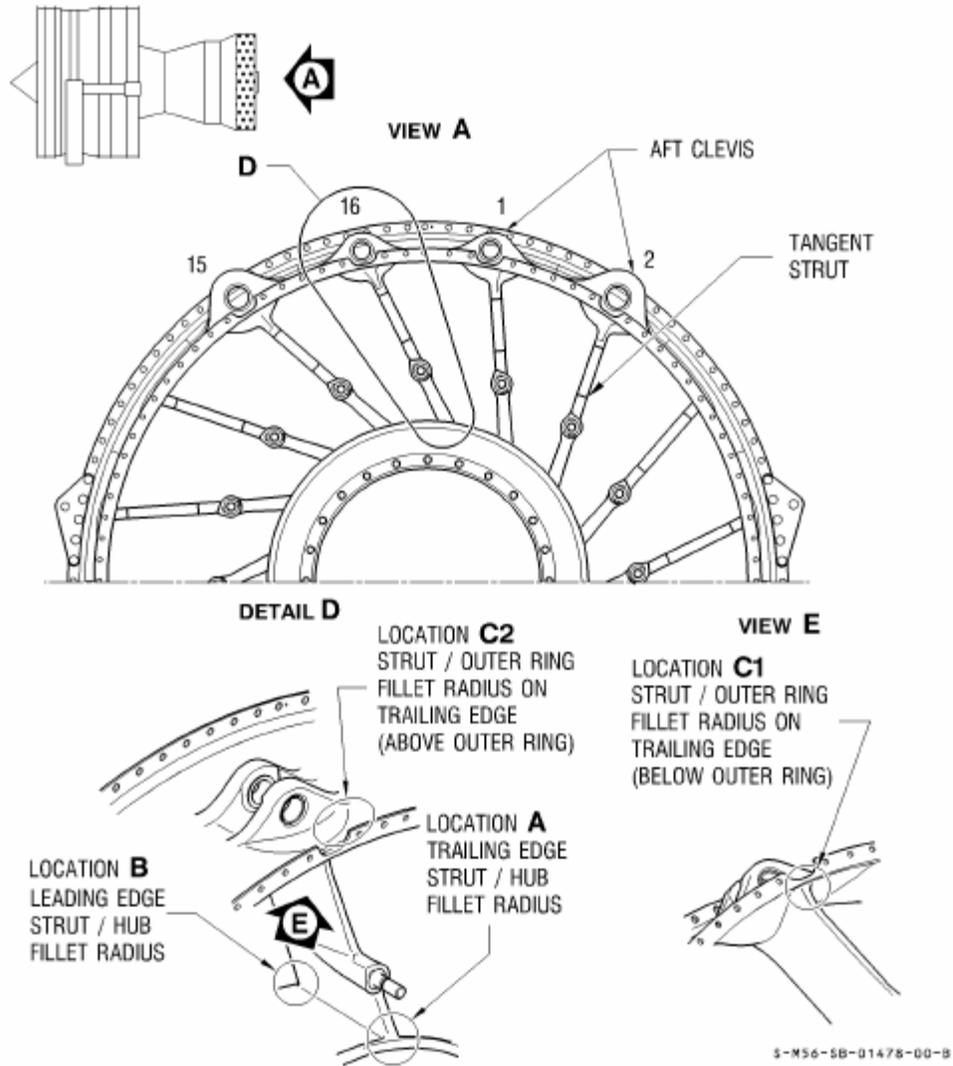
**Figure 805**

(d) This AD results from a refined lifing analysis by the engine manufacturer that shows the need to identify an initial threshold for inspecting certain TRFs. We are issuing this AD to prevent failure of the TRF from low-cycle fatigue cracks. Failure of the TRF could result in engine separation from the airplane, which could lead to loss of control of the airplane.

2. Mandatory Inspection Intervals for the Critical Areas of the Turbine Rear Frame with Tangential Struts (4 Mount Struts, No. 1, 2, 15, and 16).
  - C. Turbine Rear Frame Part Numbers 340-166-205-0, 340-166-206-0, 340-166-207-0, 340-166-208-0, 340-166-209-0, 340-166-210-0, for all CFM56-7B SAC engine models (except -7B27A engine models). Refer to figure 805.

Figure Index No.	Inspection Location	Inspection Threshold (Cycles since new)	Inspection Intervals (Cycles)	Inspection Reference
805	Strut/outer ring fillet radius on trailing edge (A)	25,000* for -7B SAC (except business jet) engine models	Refer to Figure 806* for -7B SAC (except business jet) engine models	Refer to SB 72-0579*
	Strut/hub fillet radius on leading edge (B)	19,000* for -7B SAC business jet engine models	Refer to Figure 807* for -7B SAC business jet engine models	
	Strut/outer ring fillet radius on trailing edge (C1 below outer ring)			
	Strut/outer ring fillet radius on trailing edge (C2 above outer ring)

NOTE: \* Applicable to all inspection locations.  
If inspection is not performed, part must be removed.

Turbine Rear Frame with Tangential Struts P/N 340-166-205-0,  
340-166-206-0, 340-166-207-0, 340-166-208-0, 340-166-209-0, 340-166-210-0 – Areas to Be Inspected

If no crack is found on any of the four mount struts, the turbine rear frame is serviceable and must be re-inspected at 4,700 cycle repetitive intervals. If cracks are found on the mount struts, the TRF must be re-inspected according to the following repetitive intervals:

<b>TOTAL CUMULATED CRACK LENGTH AT EACH LOCATION</b>	<b>RE-INSPECT WITHIN</b>
$L < 0.20$ (5)	4,700
$0.20 (5) \leq L < 0.28$ (7)	3,300
$0.28 (7) \leq L < 0.39$ (10)	1,300
$0.39 (10) \leq L < 0.59$ (15)	700
$0.59 (15) \leq L < 0.79$ (20)	120
$L \geq 0.79$ (20)	IMMEDIATELY REMOVE THE TURBINE FRAME

During each inspection, all the locations must be inspected. If cracks are found at different locations, the repetitive inspection interval is the minimum interval corresponding to the max. cumulated crack lengths.
