PŘÍKAZ K ZACHOVÁNÍ LETOVÉ ZPŮSOBILOSTI

Číslo: EASA 2010-0237R2

Agusta S.p.A. – AB139, AW139

EASA	AIRWORTHINESS DIRECTIVE

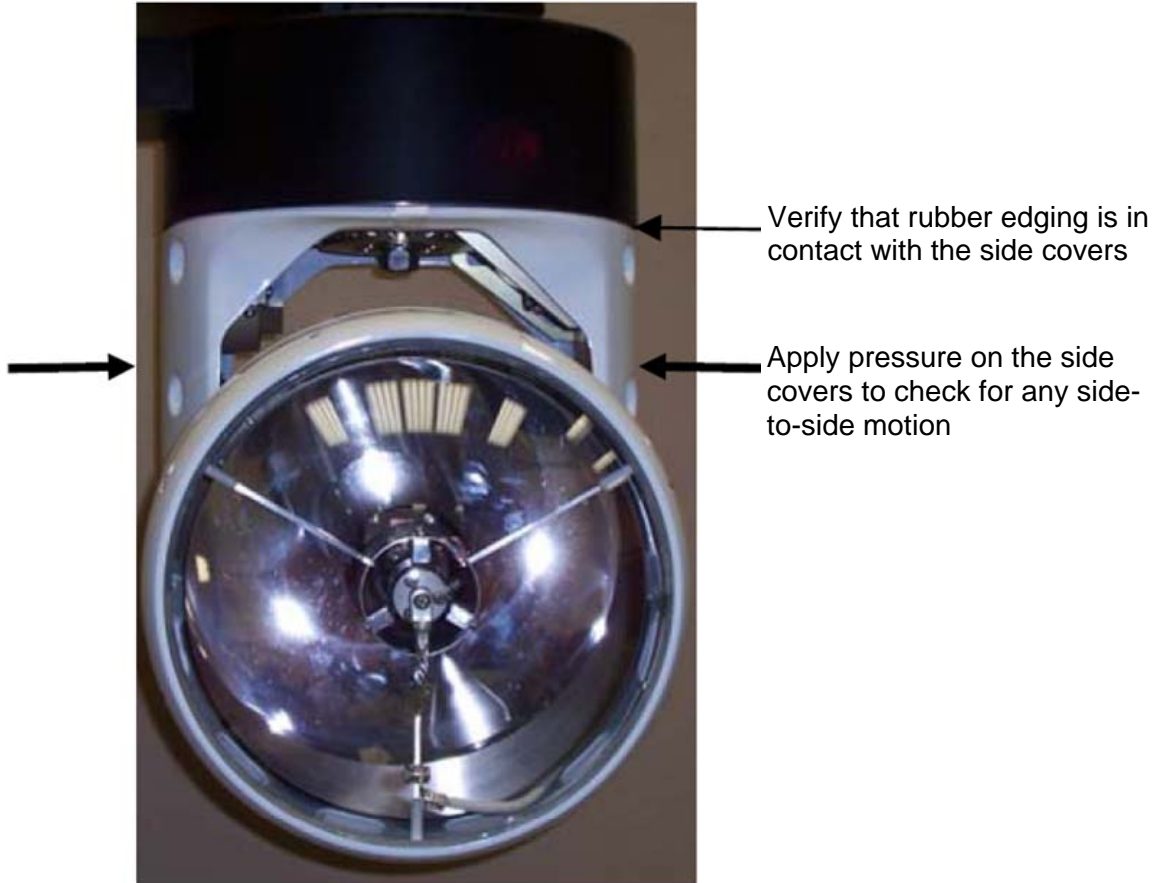
Appendix 1 – Photo showing location to be checked

Reason:	<p>An incident has been reported by a Maintenance Organisation of vibration associated with the Nightsun XP Searchlight. Investigation revealed that the Gimbal Azimuth Top Hex Nut was loose.</p> <p>This condition, if not detected and corrected, could lead to a gap between the rubber edging of the top shroud and the Gimbal frame, resulting in degradation of pointing accuracy and stability performance and pose excessive vibration. If the nut were to entirely disengage, the Searchlight/Gimbal could disconnect from the helicopter and remain attached solely by the internal cable harness or separate totally, possibly resulting in damage to the helicopter or injury to persons on the ground.</p> <p>EASA issued Emergency AD 2010-0183-E, later revised, as an interim measure to require repetitive inspections and, depending on findings, the removal of the searchlight from the helicopter.</p> <p>Spectrolab, the Searchlight manufacturer, has now developed a modification of the Searchlight installation that remedies the problem by replacing the Nightsun XP gimbal azimuth top hex nut with a dual-locking nut. This action includes re-identification of the gimbals as either P/N 033295-3 or P/N 033295-4 and assigns accordingly a new airworthy revision standard to the P/N of the modified Nightsun XP Searchlight Assembly.</p> <p>One of the affected approval holders, Eurocopter UK Ltd, subsequently developed the EASA-approved modifications which allow embodiment of the Spectrolab design changes on helicopters modified by Eurocopter UK STC.</p> <p>For the reasons described above, EASA AD 2010-0237 was issued, retaining the inspection requirements of AD 2010-0183R1, which was superseded, required removing the searchlight from the helicopter and allowed, for the affected Eurocopter Deutschland GmbH helicopters, modification of the searchlight installation by installing a modified searchlight assembly, having a higher revision standard and a new P/N Gimbal assembly.</p> <p>Since AD 2010-0237 was published, the other affected approval holders have developed their own modifications, which have been approved by EASA, to allow embodiment of the Spectrolab design change on Agusta AB139 and AW139 helicopters, and on Sikorsky S-92A helicopters modified by Keystone STC, respectively.</p> <p>Revision 1 of this AD was issued to include reference to Agusta Bollettino Tecnico (BT) 139-231 and Keystone Helicopter Corporation Service Bulletin (SB) 10-11 revision C, which provide the terminating action instructions for the AB139, AW139 and S-92A helicopters affected by this AD. In addition, this AD reduces the applicability to helicopters that have Gimbal Assembly P/N and Searchlight Assembly P/N as defined in Table 1 of the Applicability section of this AD.</p> <p>Revision 2 of this AD is issued to allow installation of a Searchlight Assembly with a higher Revision number than required by this AD, provided that the applicable (Supplemental) Type Certificate holder has certified the installation of a Searchlight Assembly with that Revision number.</p>

<p>side covers.</p> <p>(1.2) Try to move the Searchlight laterally. No gap should appear between the Top Shroud rubber edging (P/N 033381) and the side covers (P/N 033286) and no play should be felt.</p> <p>Appendix 1 of this AD shows the area(s) to be checked.</p> <p>(2) If, during any of the checks as required by paragraph (1) of this AD discrepancies are detected, before next flight, remove the searchlight assembly from the helicopter and contact the design (change) approval holder, as applicable to the installation.</p> <p>(3) Within 30 days after 30 November 2010 [the effective date of the original issue of this AD], irrespective of findings, remove the searchlight assembly from the helicopter, as applicable to the installation, or,</p> <p>(3.1) For Eurocopter Deutschland GmbH helicopters, install a P/N 033338 Revision F Searchlight Assembly, in accordance with the instructions of Eurocopter UK Ltd Service Bulletin (SB) 135787-467, SB 1351151-472, or SB 1451167-473, as applicable to helicopter Model.</p> <p>(3.2) For Agusta helicopters, install a P/N 033338 Revision F Searchlight Assembly, in accordance with the instructions of Agusta BT 139-231.</p> <p>(3.3) For Sikorsky helicopters, install a P/N 033338-3 Revision E Searchlight Assembly or a P/N 033704 Revision D Searchlight Assembly, as applicable to the installation, in accordance with the instructions of Keystone Helicopter Corporation SB 10-11 rev. C.</p> <p>(3.4) For all helicopters, installation of a Searchlight Assembly with a higher Revision number than those required by paragraphs (3.1), (3.2), or (3.3) of this AD, as applicable to type design (change), is allowed, provided that the applicable (Supplemental) Type Certificate holder has certified the installation of a Searchlight Assembly with that Revision number.</p> <p>(4) Modification of a helicopter as required by paragraph (3) of this AD constitutes terminating action for the repetitive inspection requirements of this AD.</p> <p>(5) From the effective date of this AD:</p> <p>(5.1) Do not install a Spectrolab Nightsun XP Gimbal Assembly P/N 033295-1 or P/N 033295-2 on any helicopter as a replacement unit.</p> <p>(5.2) Do not modify a helicopter by installing a Spectrolab Nightsun XP Searchlight Assembly affected by this AD, unless in compliance with paragraph (3.1), (3.2), (3.3) or (3.4) of this AD, as applicable to helicopter type.</p>

Effective Date:	<p>Revision 2: 14 December 2010</p> <p>Revision 1: 06 December 2010</p> <p>Original issue: 30 November 2010.</p>
Required Action(s) and Compliance Time(s):	<p>Required as indicated, unless previously accomplished:</p> <p>(1) Before the next flight after 31 August 2010 [the effective date of EASA AD 2010-0183-E], and thereafter before the first flight of each day, accomplish the following actions:</p> <p>(1.1) Visually check the searchlight installation Gimbal for a gap between the Top Shroud rubber edging (P/N 033381) and the side covers (P/N 033286). The edging should be in physical contact with the</p>
