## PŘÍKAZ K ZACHOVÁNÍ LETOVÉ ZPŮSOBILOSTI

**Číslo: FAA AD 2011-06-05**

**Boeing Company**

#### **Airworthiness Directives; The Boeing Company Model 737-600, -700, -700C, -800, -900, and -900ER Series Airplanes**

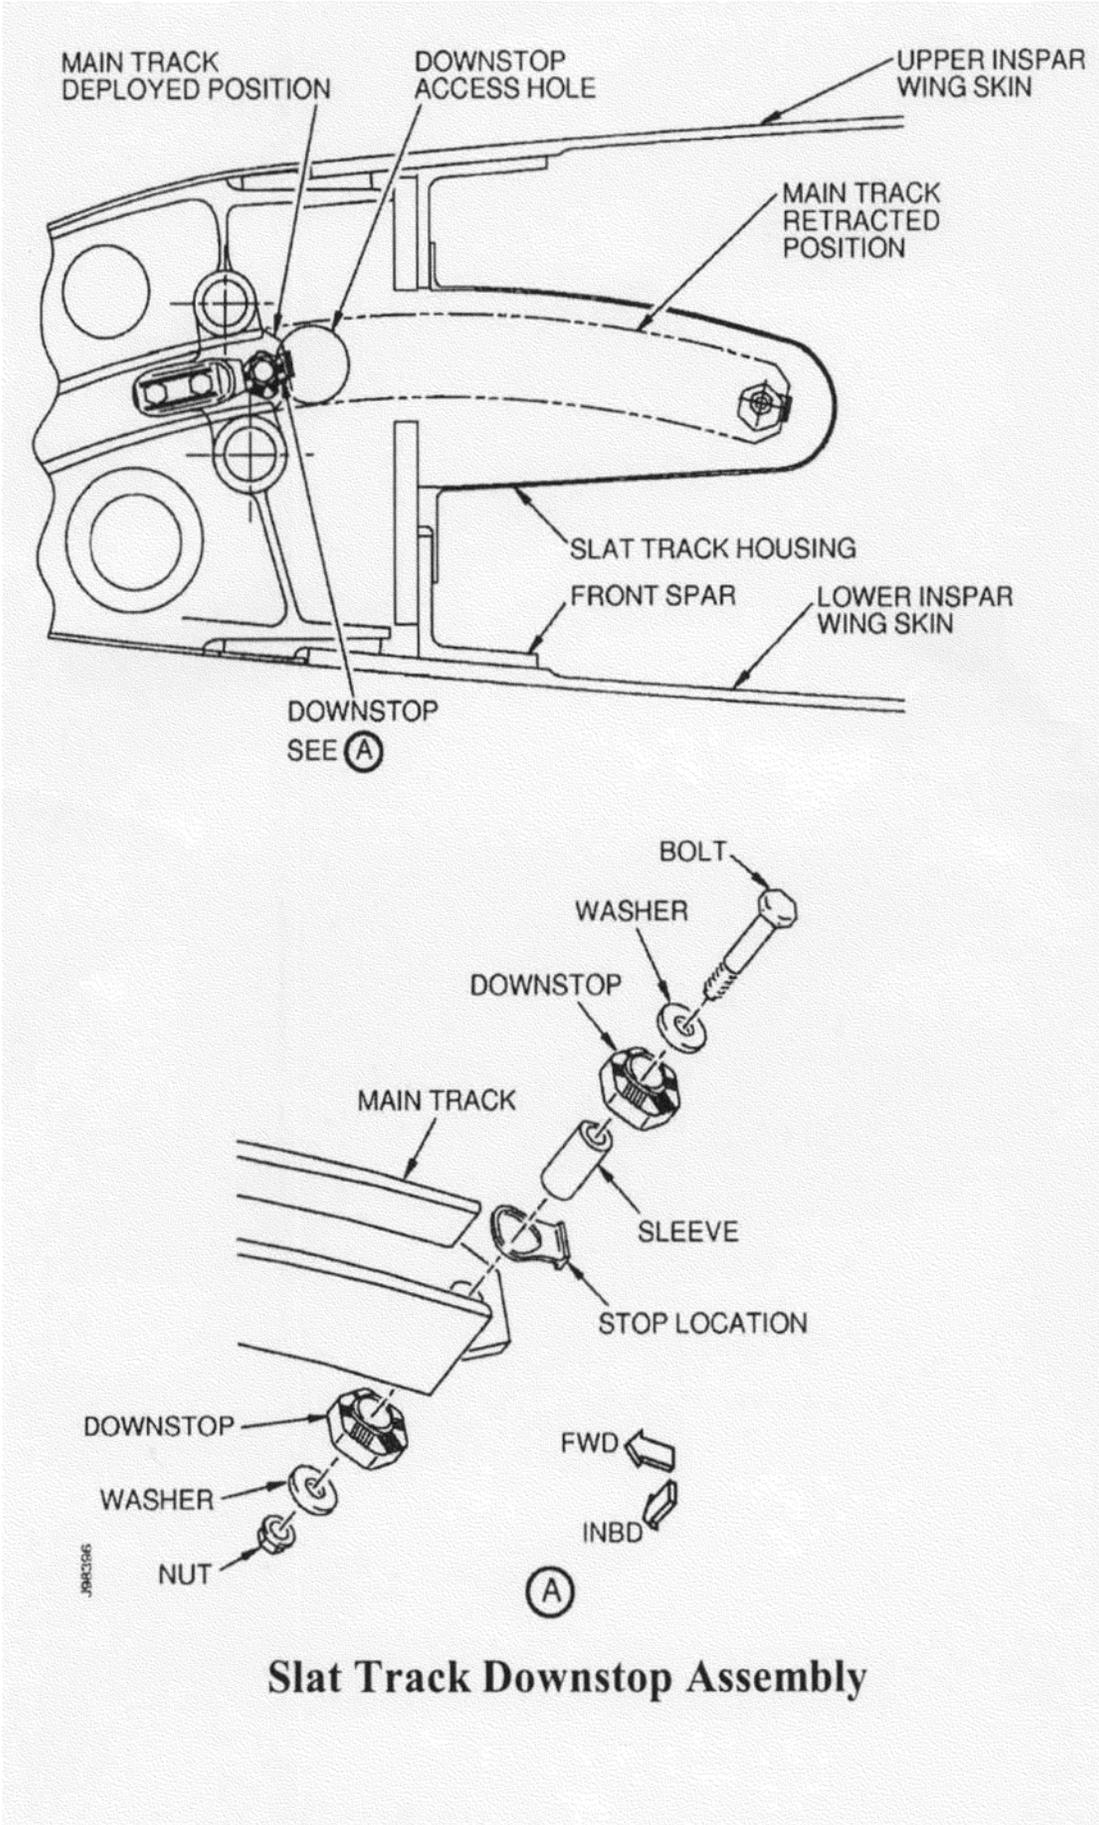
**Figure 1**

(g) Within 10 days after September 26, 2007 (the effective date of AD 2007-18-52): Do a detailed inspection or a borescope inspection of each main slat track downstop assembly to verify

proper installation of the slat track hardware (i.e., the bolt, washers, downstops, stop location, and nut shown in Figure 1 of Boeing Service Letter 737-SL-57-084-B, dated July 10, 2007, and in this AD). Proper installation of the sleeve need not be confirmed, and the stop location part may be installed on either the inboard or the outboard side of the slat track. If any part is missing or is installed improperly, before further flight, install a new or serviceable part using a method approved in accordance with the procedures specified in paragraph (j) of this AD; and do a detailed inspection of the inside of the slat can for foreign object debris (FOD) and damage. Before further flight, remove any FOD found and repair any damage found using a method approved in accordance with the procedures specified in paragraph (j) of this AD. Verify proper installation; install a new or serviceable part; and inspect for damage and FOD, and remove FOD and repair damage; in accordance with a method by approved by the Manager, Seattle Aircraft Certification Office, FAA; or in accordance with Boeing Multi Operator Message Number 1-523812011-1, issued August 25, 2007, or 1-527463441-1, issued August 28, 2007. Repeat the actions required by paragraph (g) of this AD thereafter at intervals not to exceed 3,000 flight cycles.

(h) Within 24 days after receipt of emergency AD 2007-18-51: Apply a torque between 50 to 80 inch-pounds to the nut. The bolt head must be held with the torque applied to the nut.
