[Docket No. FAA-2009-1253; Directorate Identifier 2009-NM-080-AD; Amendment 39-16629; AD 2011-06-05]

Airworthiness Directives; The Boeing Company Model 737-600, -700, -700C, -800, -900, and -900ER Series Airplanes

ACTION: Final rule.

2011-06-05 The Boeing Company: Amendment 39-16629. Docket No. FAA-2009-1253; Directorate Identifier 2009-NM-080-AD.

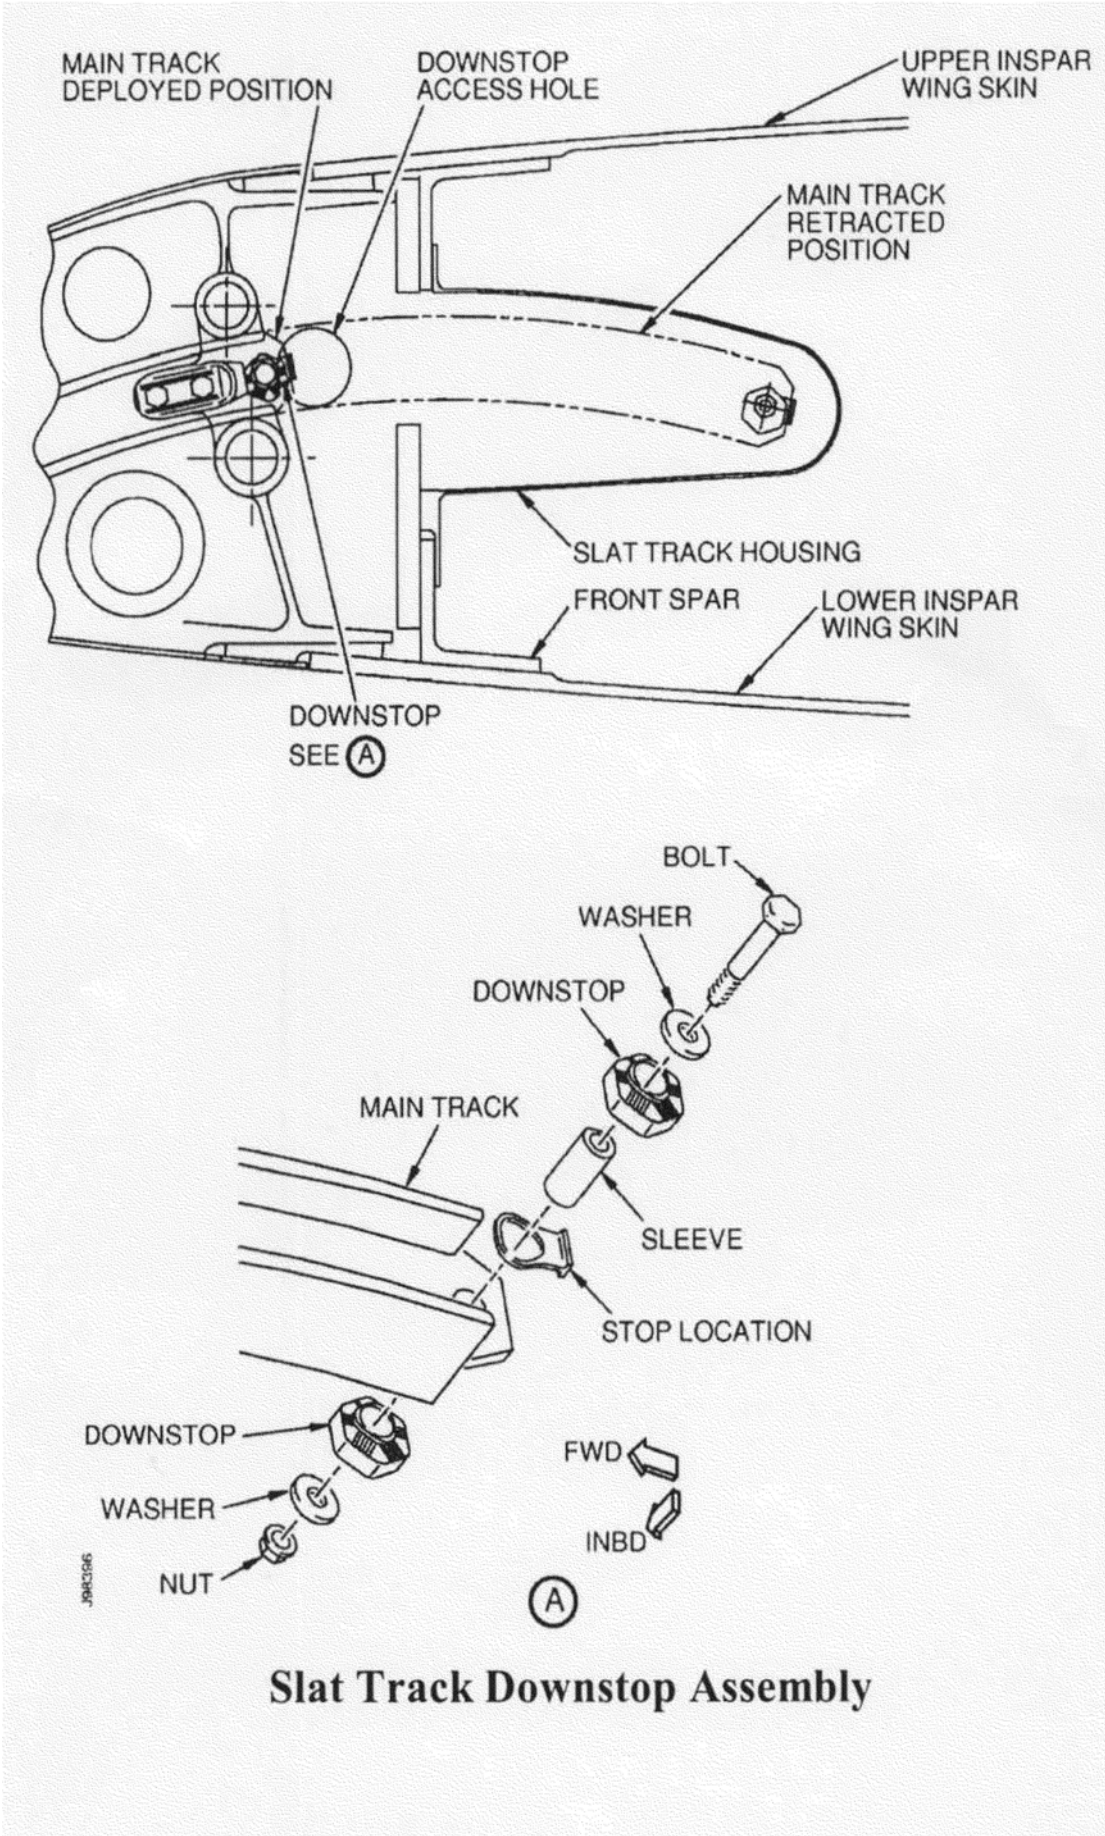
(g) Within 10 days after September 26, 2007 (the effective date of AD 2007-18-52): Do a detailed inspection or a borescope inspection of each main slat track downstop assembly to verify

proper installation of the slat track hardware (i.e., the bolt, washers, downstops, stop location, and nut shown in Figure 1 of Boeing Service Letter 737-SL-57-084-B, dated July 10, 2007, and in this AD). Proper installation of the sleeve need not be confirmed, and the stop location part may be installed on either the inboard or the outboard side of the slat track. If any part is missing or is installed improperly, before further flight, install a new or serviceable part using a method approved in accordance with the procedures specified in paragraph (j) of this AD; and do a detailed inspection of the inside of the slat can for foreign object debris (FOD) and damage. Before further flight, remove any FOD found and repair any damage found using a method approved in accordance with the procedures specified in paragraph (j) of this AD. Verify proper installation; install a new or serviceable part; and inspect for damage and FOD, and remove FOD and repair damage; in accordance with a method by approved by the Manager, Seattle Aircraft Certification Office, FAA; or in accordance with Boeing Multi Operator Message Number 1-523812011-1, issued August 25, 2007, or 1-527463441-1, issued August 28, 2007. Repeat the actions required by paragraph (g) of this AD thereafter at intervals not to exceed 3,000 flight cycles.

(h) Within 24 days after receipt of emergency AD 2007-18-51: Apply a torque between 50 to 80 inch-pounds to the nut. The bolt head must be held with the torque applied to the nut.
