PŘÍKAZ K ZACHOVÁNÍ LETOVÉ ZPŮSOBILOSTI

Číslo: 83-08-01R2

Hartzell Propeller Inc.

Airworthiness Directives; Hartzell Propeller Inc. (Formerly TRW Hartzell Propeller) Models HC-B3TN-2, HC-B3TN-3, HC-B3TN-5, HC-B4TN-3, HC-B4TN-5, HC-B4MN-5, and HC-B5MP-3 Turbopropellers

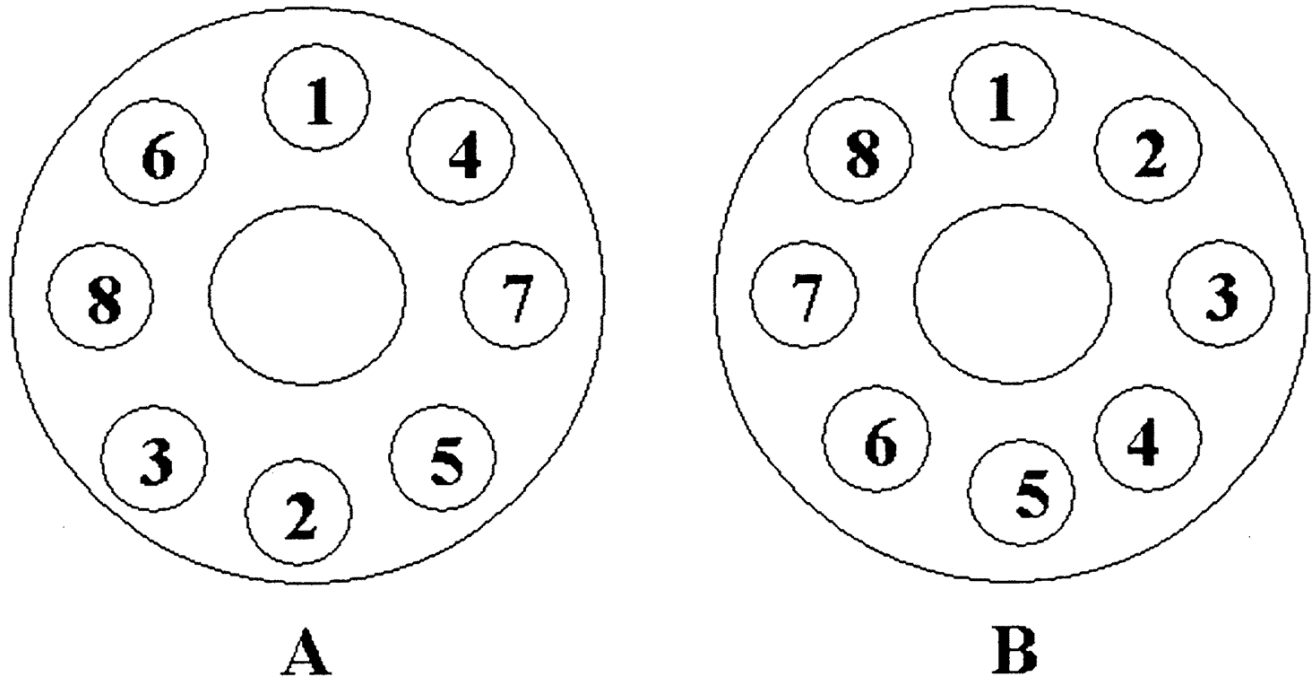
(5) Torque all attaching bolts with a torque wrench and an appropriate adapter, to 40 ft.-lbs., and then to 80 ft.-lbs., following sequence "A" (shown below). Final torque all attaching bolts using sequence "B" (shown below) to 100 ft.-lbs. to 105 ft.-lbs. Safety wire all attaching bolts in an FAA-approved manner.
