Airworthiness Directive

DCA/750XL/8 Fuselage Roof, Station 180.85 – Inspection and Repair

PACSB / XL / 019

INSPECTION – Fuselage roof, Station 180.85

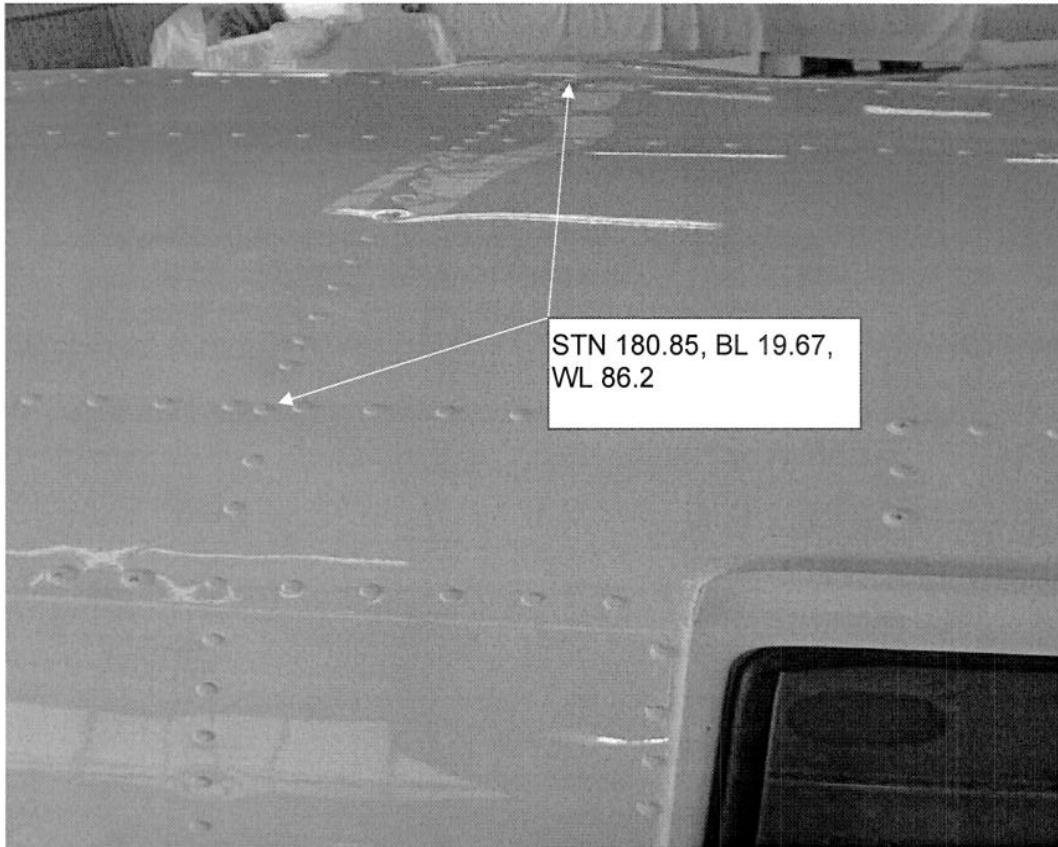
Figure 1

During routine inspection of an aircraft during release to service at Pacific Aerospace Corporation, it was identified that a row of 1/8" solid rivets had been incorrectly fitted where 5/32" solid rivets had been specified in the fuselage top (43 locations). STN 180.85, BL 19.67, WL 86.2 (Fig 1)

- 2.1 At the co-ordinates specified visually inspect to determine that the correct rivet 5/32" has been installed. Using aids as necessary, (e.g. verniers) examine the rivet heads in the positions indicated. Refer to the illustration (Fig 1) which shows the fuselage roof.
- 2.2 The rivet heads at the points arrowed should be those of 5/32" rivets, clearly larger than those (1/8"). As a guide the head of the 5/32" rivet should measure \varnothing 0.327" the incorrect 1/8" rivet head size should measure \varnothing 0.289".
- 2.3 If rivets are 5/32", no further work is required complete section 4.0 of this SB.
- 2.4 If the rivets appear to be 1/8", proceed as in part 3.0.

- 3.1 Incorrect rivets to be removed and replaced using the following rivet type MS20470AD5 (43). Components are available from Pacific Aerospace Customer Service.
 - Referring to the Maintenance Manual, Chapters 25 & 53 remove the Roof cabin linings.
 - Drill the heads and remove the 1/8" rivets one at a time, following normal rivet removal procedure.
 - As each rivet is removed, drill the hole out to 5/32", then ream using a number 21 (0.159") ream.
 - Install and drive an MS20470AD5 rivet.
 - Proceed until all 43 affected rivets have been replaced.
 - Paint in accordance with standard aircraft practices refer to Maintenance Manual Chapter 20.
- 3.2 Reinstall the cabin lining referring to the Maintenance Manual, Chapter 25.
