## PŘÍKAZ K ZACHOVÁNÍ LETOVÉ ZPŮSOBILOSTI

**Číslo: A- 2005-003**

**Diamond Aircraft Industries GmbH**  
model DA 42

Exchange of the Wing Stub Safety Walks,  
Revision of the Airplane Flight Manual  
Single Engine Rate of Climb/Descent

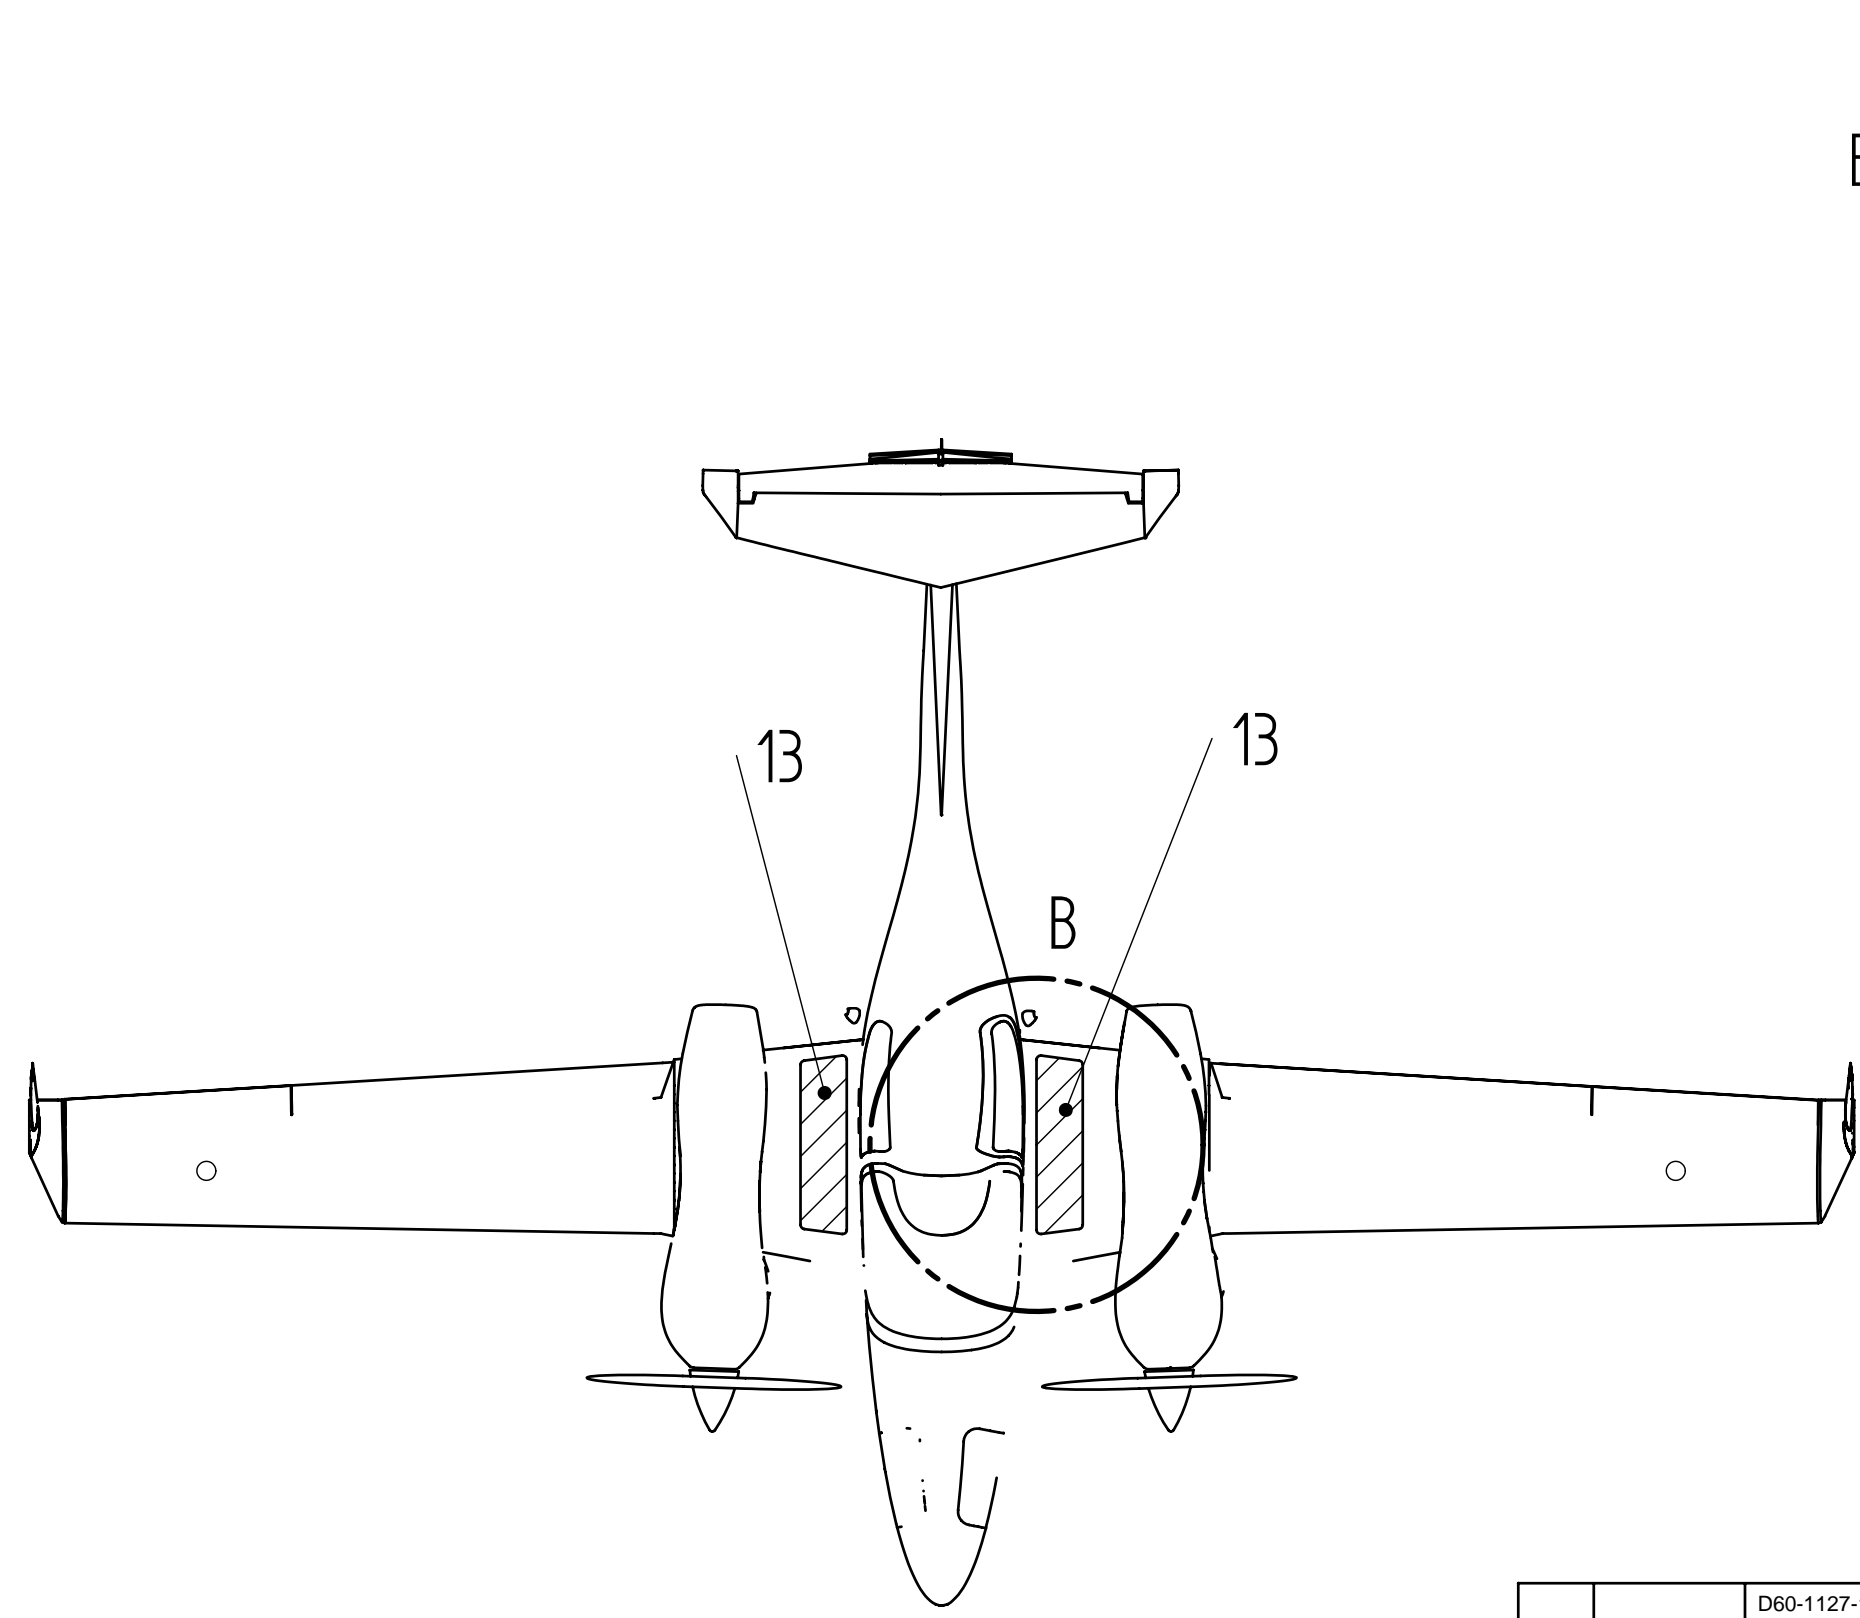
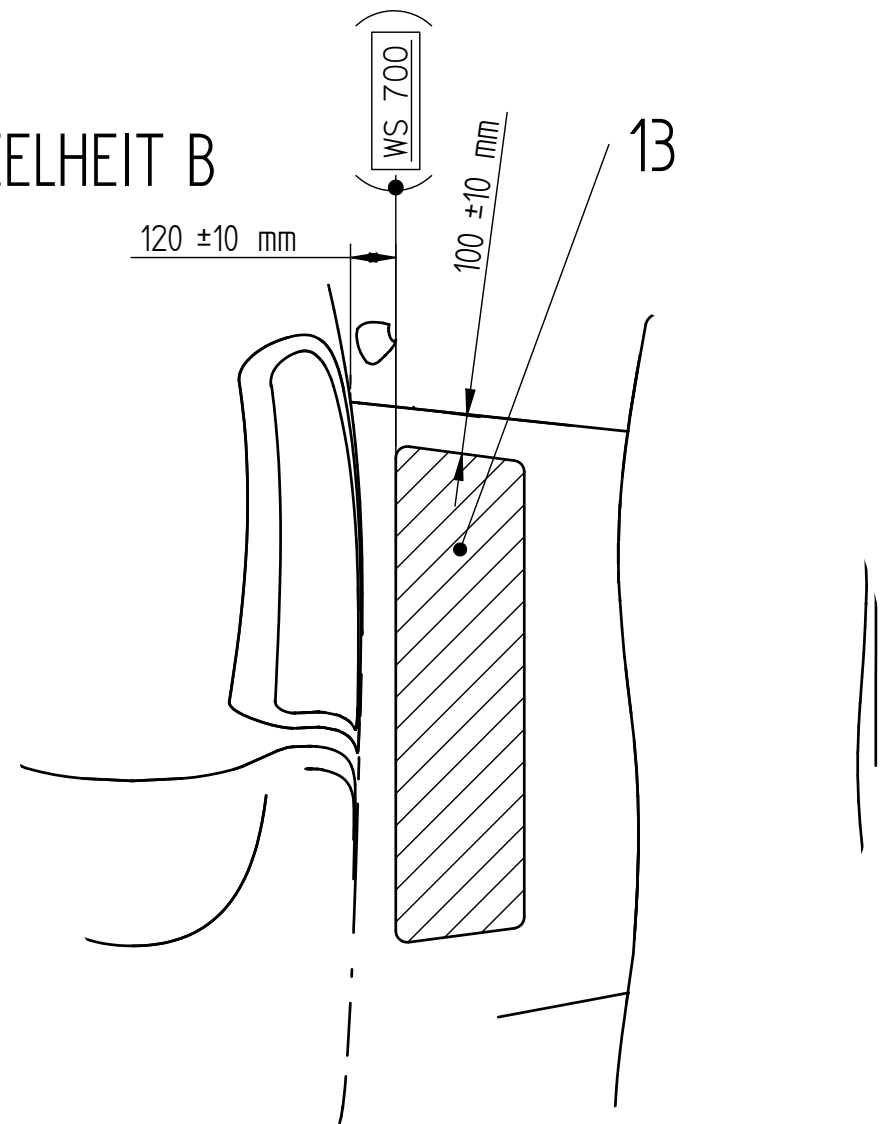
AD A-2005-003 (EASA Approval No. 2005-6381) supersedes AD A-2005-001R1 (EASA Approval No. 2005-6181).
3. Reason: It has been determined that the surface roughness of the wing stub safety walks Series 300, gray color (equals sandpaper grid 40), installed during production on some aeroplane S/Ns, adversely affects the aircraft single engine climb performance.

It has been found that the airplane fails to reach the one engine inoperative climb/descent data shown in the Airplane Flight Manual. In this context it has been determined, that the Safety Walk - 300 Series, color grey –coarse surface, has an adverse influence to the rate of climb – single engine operation. Replacement is necessary. In addition to that a Temporary Revision to the Airplane Flight Manual is

- a Remove Safety Walk Series 300, color grey – coarse surface (surface roughness equal to sandpaper with grid 40). For replacement refer to AMM, Chapter 11-00.
- b Install new Safety Walk D60-1127-10-51 Rev. “a” or later issue (surface roughness equal or finer than sandpaper grid 100) according to drawing D60-1120-20-00SB, latest effective revision. For replacement refer to AMM, Chapter 11-00.
- c Remove AFM-TR-MÄM-42-070, page 5-18a, and AFM-TR-MÄM-42-103, page 5-18b.
- d Mark AFM page 5-18 as superseded.
- e Incorporate Temporary Revision TR-MÄM-42-111/a into the AFM.
- f MSB 42-005 becomes obsolete with compliance to MSB 42-006/1 or later.
