PŘÍKAZ K ZACHOVÁNÍ LETOVÉ ZPŮSOBILOSTI

CAA-AD-012/2001

MOTOR – „PS3 LINE FITTINGS“ - KONTROLA

2001-02-12 CFM International: Amendment 39-12097. Docket No. 2001-NE-03-AD.

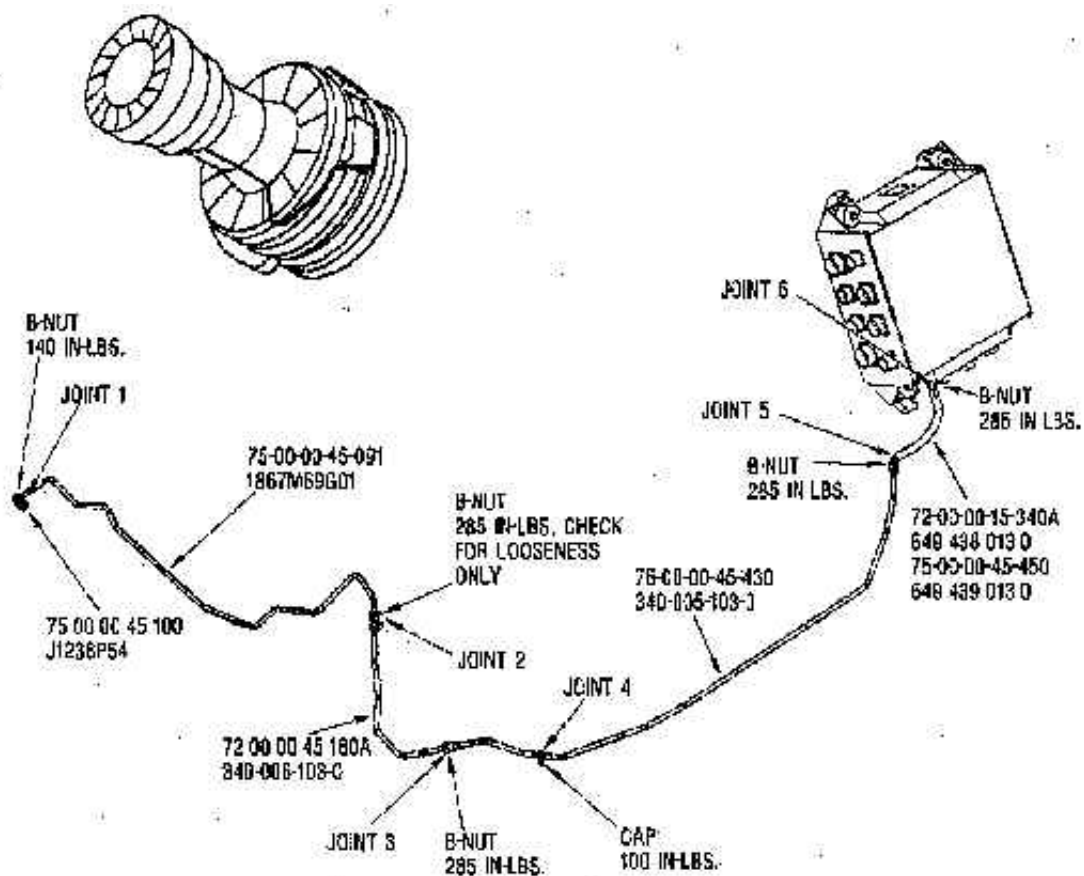
Figure 1. Torque Values for PS3 Line Fittings

To prevent air leakage from incorrectly torqued fittings of the PS3 pressure line, which could result in engine power loss, do the following:

(a) Check for and apply the correct torque in the tightening direction of all PS3 pressure line fittings as identified in Figure 1 of this AD as Joint 1, Joint 2, Joint 3, Joint 4, Joint 5, and Joint 6 as follows:

- (1) Torque Joint 1 to ensure a torque value of 140 inch-pounds.
- (2) Due to accessibility limitations, check Joint 2 for finger looseness, and only if loose, torque to a value of 285 inch-pounds.
- (3) Torque Joint 3, Joint 5, and Joint 6 to ensure a torque value of 285 inch-pounds.
- (4) Torque Joint 4 to ensure a torque value of 100 inch-pounds.
