PŘÍKAZ K ZACHOVÁNÍ LETOVÉ ZPŮSOBILOSTI

CAA-AD-T-115/2001

VRTULNÍK - SILOVÝ UZEL PŘÍHRADOVÉ KONSTRUKCE DRAKU – KONTROLA/VÝMĚNA

2001-25-52 SCHWEIZER AIRCRAFT CORPORATION: Docket No. 2001-SW-58-AD. Supersedes 76-18-01, Amendment No. 39-2707, Docket No. 72-WE-23-AD.

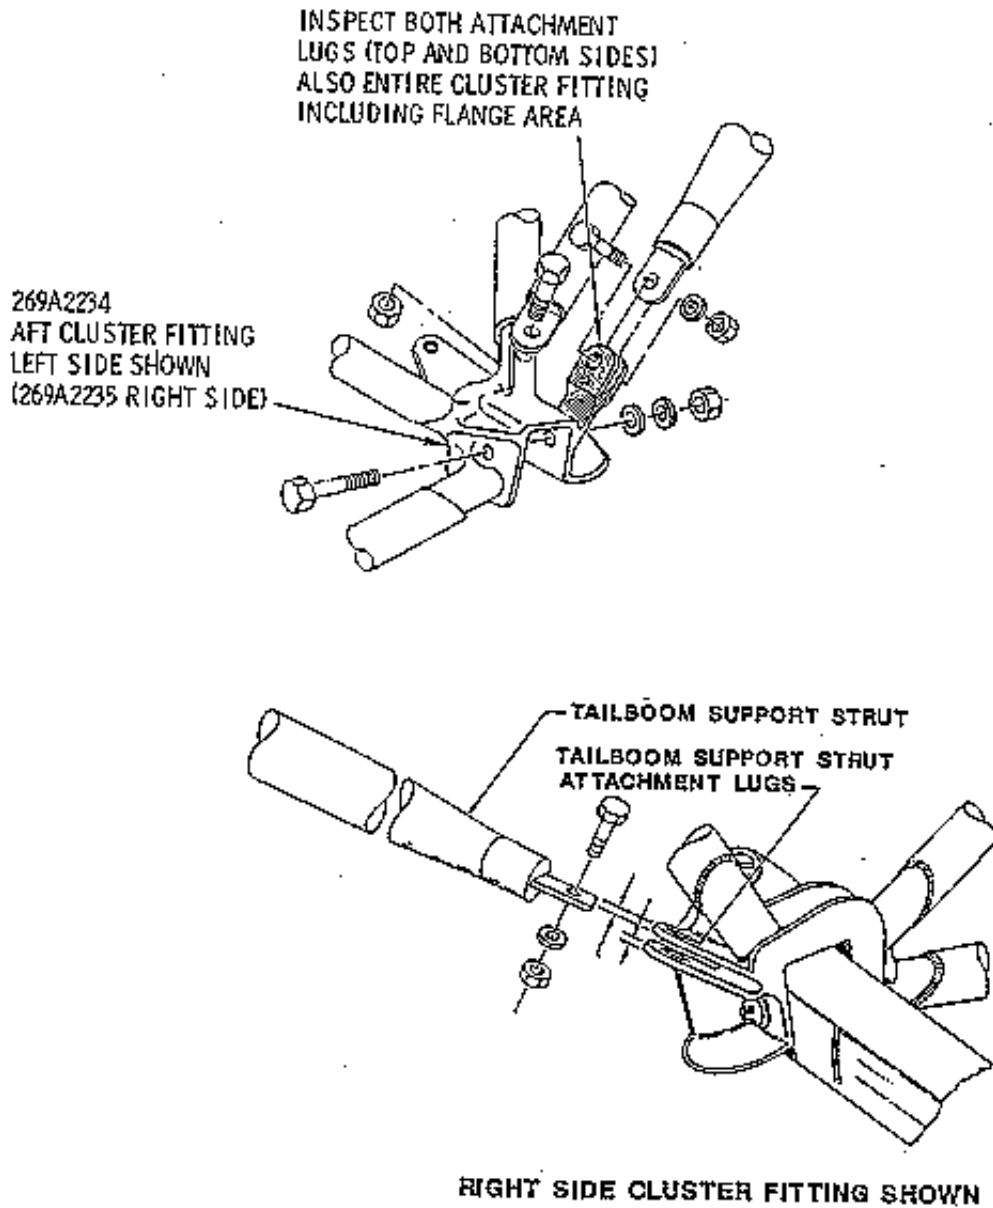
Figure 1

To prevent failure of a strut clevis lug (lug) on a center frame aft cluster fitting (cluster fitting), rotation of a tailboom into the main rotor blades, and subsequent loss of control of the helicopter, accomplish the following:

(2) Dye-penetrant inspect the lugs on each aft cluster fitting. See Figure 1.

(1) Using paint remover, remove paint from the lugs on each aft cluster fitting. Wash with water and dry.

(3) If a crack is found, before further flight, replace the cracked cluster fitting with an airworthy cluster fitting. Cluster

fittings, P/N 269A2234 and 269A2235, are not eligible to replace a cracked cluster fitting.
