**Číslo: DCA/750XL/3A**

### **DCA/750XL/3A      Wiring Loom Protective Sleeve – Inspection and Installation**

PACSB / XL / 009 Issue 2

### INSPECTION – WIRING LOOM PROTECTIVE SLEEVE

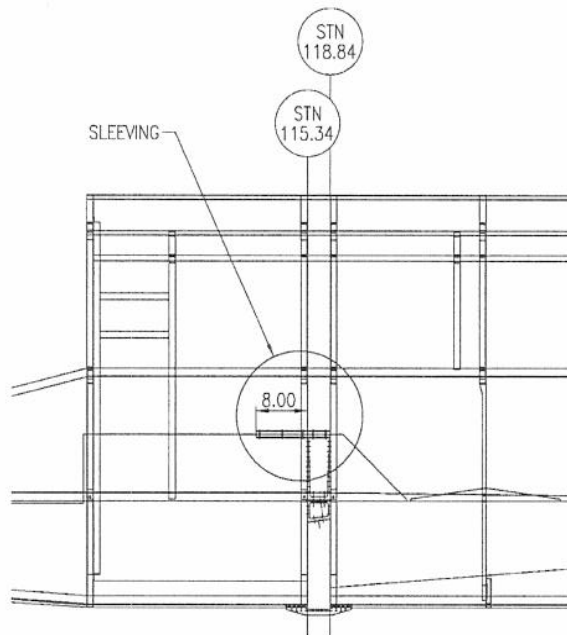
| C. | DESCRIPTION | Two pieces of protective sleeving should be present, wrapped around the main loom on the RHS of the aircraft adjacent to the frames at stations 115.34" and 118.84". This inspection is to determine that the sleeving is actually present. |

1. Remove the interior lining on the RHS of the fuselage above the wing spar. (Refer MM Ch 25, 25-10-00, page 401.)
2. Examine the loom as it passes the fuel vent lines adjacent to stations 115.34" and 118.84". There should be clearly visible, dark green or clear plastic sleeve wire-tied around the loom at these points. Refer illustration.

1. If sleeving is present, the longer sleeve will extend 8" forward of station 115.34", and the shorter (3.5") sleeve should fill the gap between the frames. If all is correct, reinstall the linings.
2. If missing, order part number SLE2-1-080S (8") and/or SLE2-1-035S sleeves from PAC spares. To install, position as indicated on the drawing excerpt, wrap around the loom and position as illustrated above. Wire-tie the sleeves as illustrated.
