PŘÍKAZ K ZACHOVÁNÍ LETOVÉ ZPŮSOBILOSTI

Číslo: DCA/750XL/13

- DCA/750XL/13** **Aileron Inboard Hinge Attachment – Inspection and Modification**
- Applicability:** Model PAC 750XL aircraft, S/N 101, 102, 104 through to 120, and 122 through to 129, except aircraft with modification PAC/XL/0285 already embodied.
- Requirement:** To prevent cracks developing in the aileron spar adjacent to the inboard hinge attachment accomplish the following:
- Remove both ailerons, inspect and modify the aileron spar at the inboard hinge attachment point in accordance with Pacific Aerospace Ltd Service Bulletin PACSB/XL/027.
- Note:** Aileron removal, installation and rigging procedures are detailed in PAC 750XL Maintenance Manual Chapter 27-10-00.
- Compliance:** Within the next 150 hours TIS or six months, whichever occurs sooner.
- Effective Date:** 26 April 2007

REPAIR / STIFFENING AILERON INBOARD HINGE ATTACHMENT

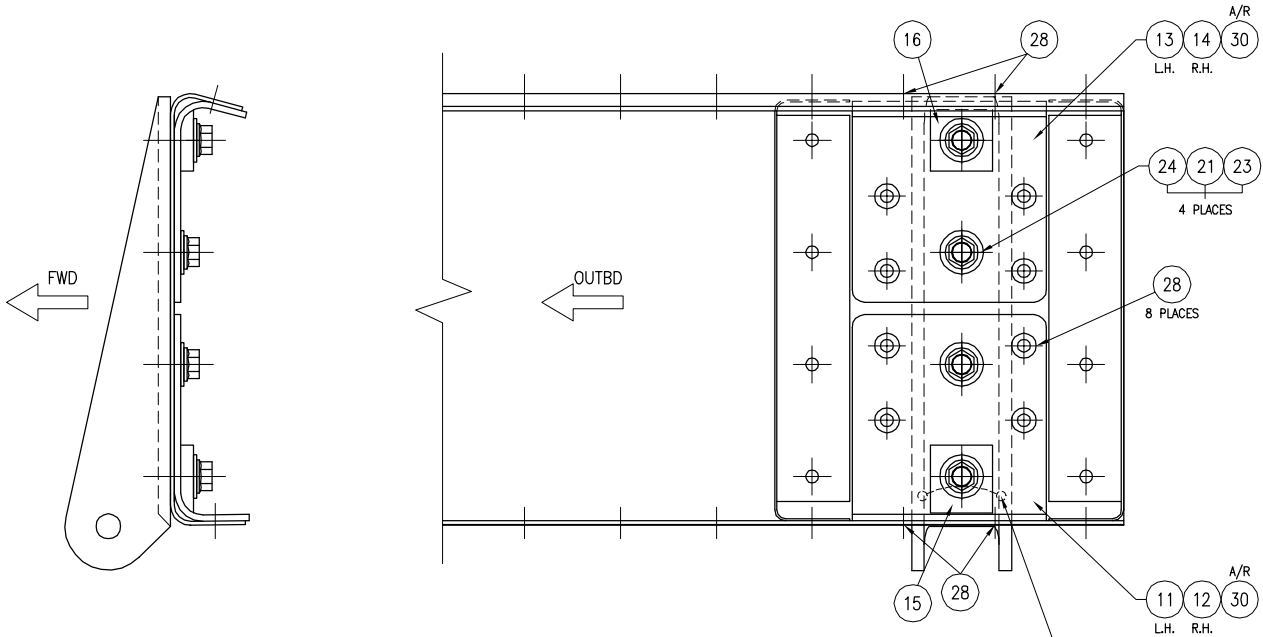
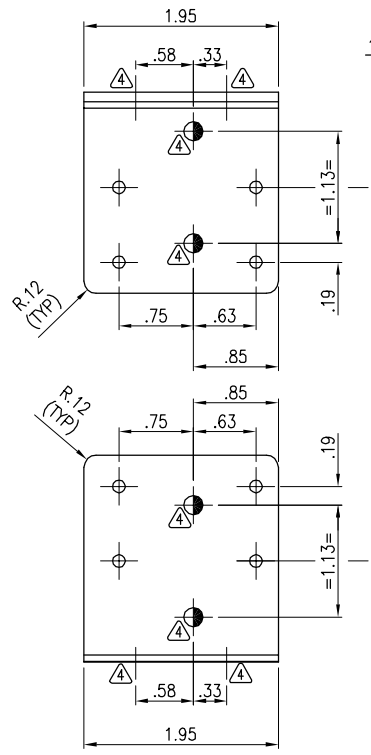
VIEW ON AILERON SPAR
 11-03141-1 (L.H.) DRAWN
 11-03142-1 (R.H.) OPPOSITE HAND

| C. | DESCRIPTION | Two cases were reported where the aileron spar started cracking at the inboard hinge attachment point. |

STOP DRILL
 CRACK IN SPAR
 IF CRACK PRESENT

⚠ DRILL TO COORD WITH EXISTING HOLES THRU SPAR.
