## PŘÍKAZ K ZACHOVÁNÍ LETOVÉ ZPŮSOBILOSTI

**Číslo: CAA New Zealand AD DCA/750XL/14**

Pacific Aerospace 750XL

### DCA/750XL/14 Rudder Pedal Assembly – Inspection and Repair

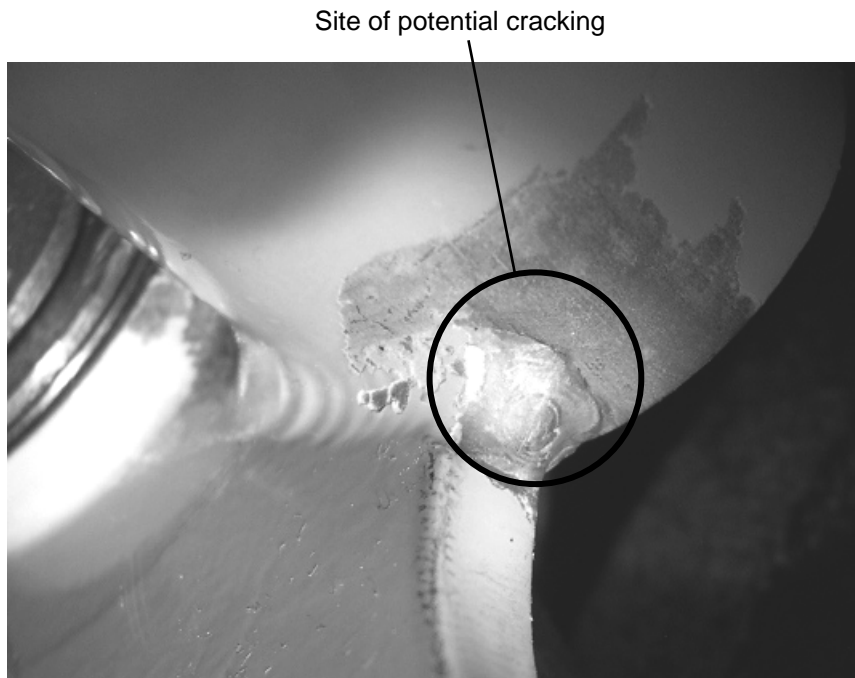
FIGURE 1 RUDDER PEDAL WELD ASSEMBLY

- B. REASON Possibility of cracks forming around the welds on the Rudder Pedal Weld Assemblies, at the rudder cable pulley.

- C. DESCRIPTION There have been instances of cracks being found on the end of the pedals where the welded rudder cable pulley is located on early 750 XL aircraft. Check the areas around the weld with a dye penetrating crack detection process. If there are any signs of cracking being present, a repair scheme needs to be incorporated.

- D. COMPLIANCE The aircraft should be inspected immediately. If there are any signs of cracks greater than ¼ inch, the aircraft should not be flown and repair scheme PAC/XL/0461 incorporated. Aircraft found with cracks less than ¼ inch should be monitored weekly and repair scheme PAC/XL/0461 incorporated at next 150 hour Inspection.

- 1) The rudder pedal weld assembly should be checked around the welds, at the rudder cable pulley, using a dye penetration technique. An example of the potential cracking is shown in Figure 1.

- 1) Remove Rudder Pedal assembly IAW P750XL Maintenance Manual, Chapter 27-20-00. **It may be possible to carry out the repair in situ.**
- 2) Carry out repair of Rudder Pedal Weld Assemblies IAW PAC/XL/0461 (refer to Drawing 11-03221/22).
- 3) Upon completion of the repair, install Rudder Pedal assembly IAW P750XL Maintenance Manual, Chapter 27-20-00.
