## PŘÍKAZ K ZACHOVÁNÍ LETOVÉ ZPŮSOBILOSTI

**Číslo: UF-2005-160**

**Aerospatiale/Alenia**  
modely ATR 42, ATR 72

**SUBJECT: TUNINTER ATR72 ACCIDENT**

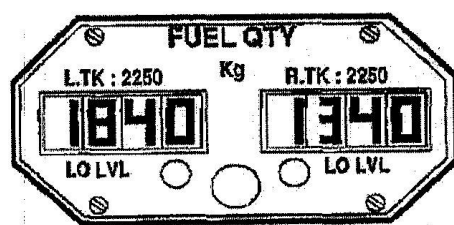
ATR 42 FQI in kg

Furthermore, the ATR42 and ATR72 indicators exhibit different front sides where the maximum fuel capacity per tank is indicated either in kilograms or pounds of fuel.

ATR recommends the operators to check that their fleet configuration related to the Fuel Quantity Indicators (3QT) is compliant with the one provided within their applicable Illustrated Part Catalog on section 28-42-80-01.
