**Číslo: 2005-13-16**

**The New Piper Aircraft, Inc.**  
model PA-34

#### **Airworthiness Directives; The New Piper Aircraft, Inc. PA-34 Series Airplanes**

**2005-13-16 The New Piper Aircraft, Inc.:** Amendment 39-14153; Docket No. FAA-2004-19960; Directorate Identifier 2004-CE-47-AD.

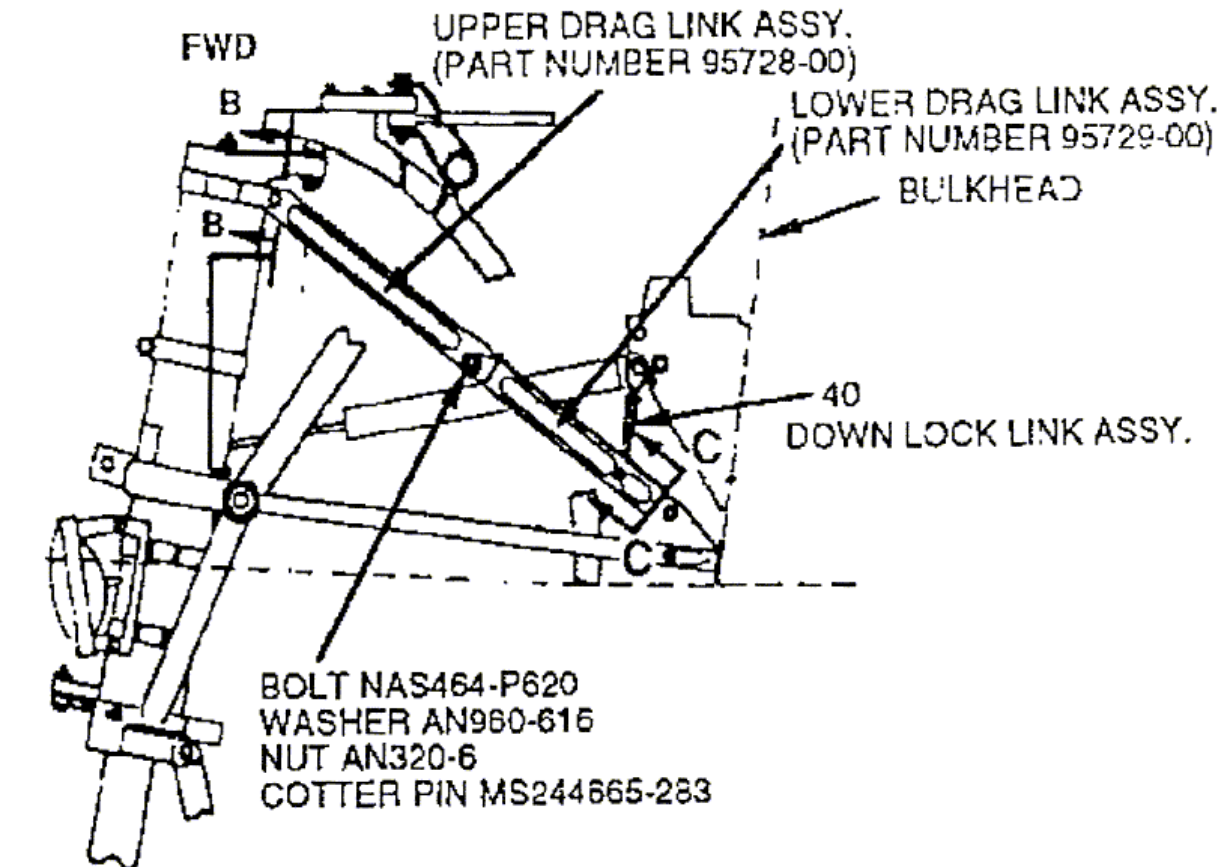
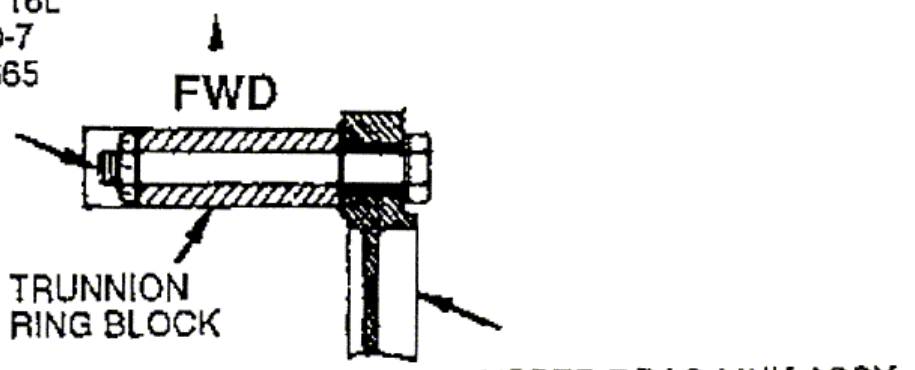
Figure 1.

SECTION B-B  
"UPPER" DRAG LINK - TO -  
GEAR CONNECTION

Actions	Compliance	Procedures
<p>(1) Replace the bolt and stack up that connects the upper drag link to the nose gear trunnion with new parts (or FAA-approved equivalent part numbers (P/N)) of the following:</p> <p>(i) Piper P/N 400 274 (AN7-35) bolt;</p> <p>(ii) Piper P/N 407 591 (AN960-716L) washer, as applicable;</p> <p>(iii) Piper P/N 407 568 (AN960-716);</p> <p>(iv) Piper P/N 404 396 (AN320-7) nut; and</p> <p>(v) Piper P/N 424 085 cotter pin.</p>	<p>Within the next 100 hours time-in-service (TIS) after January 28, 1994 (the effective date of AD 93-24-14), unless already done within the last 400 hours TIS before January 28, 1994 (compliance with AD 93-24-14). Repetitively replace thereafter at intervals not to exceed 500 hours TIS. Continue to repetitively replace until the actions in paragraphs (e)(2) and (e)(3) of this AD begin.</p>	<p>Follow Figure 1 of this AD.</p>
<p>(2) Do the inspections, replacements, and other corrective actions specified in Table 1 “Specified Maintenance” of Piper Service Bulletin No. 1123A, dated November 30, 2004.</p>	<p>Within the next 100 hours TIS after August 8, 2005 (the effective date of this AD), unless already done. Repetitively inspect thereafter at the intervals referenced in the Inspection Time column of the <i>INSTRUCTIONS</i> paragraph in Piper Service Bulletin No. 1123A, dated November 30, 2004.</p>	<p>Follow The New Piper Aircraft, Inc. Service Bulletin No. 1123A, dated November 30, 2004.</p>
