Airworthiness Directive

AD No.: 2012-0085R6

EC 135 and EC 635 helicopters

ATA 62 – Main Rotor System – Main Rotor Hub – Inspection / Replacement

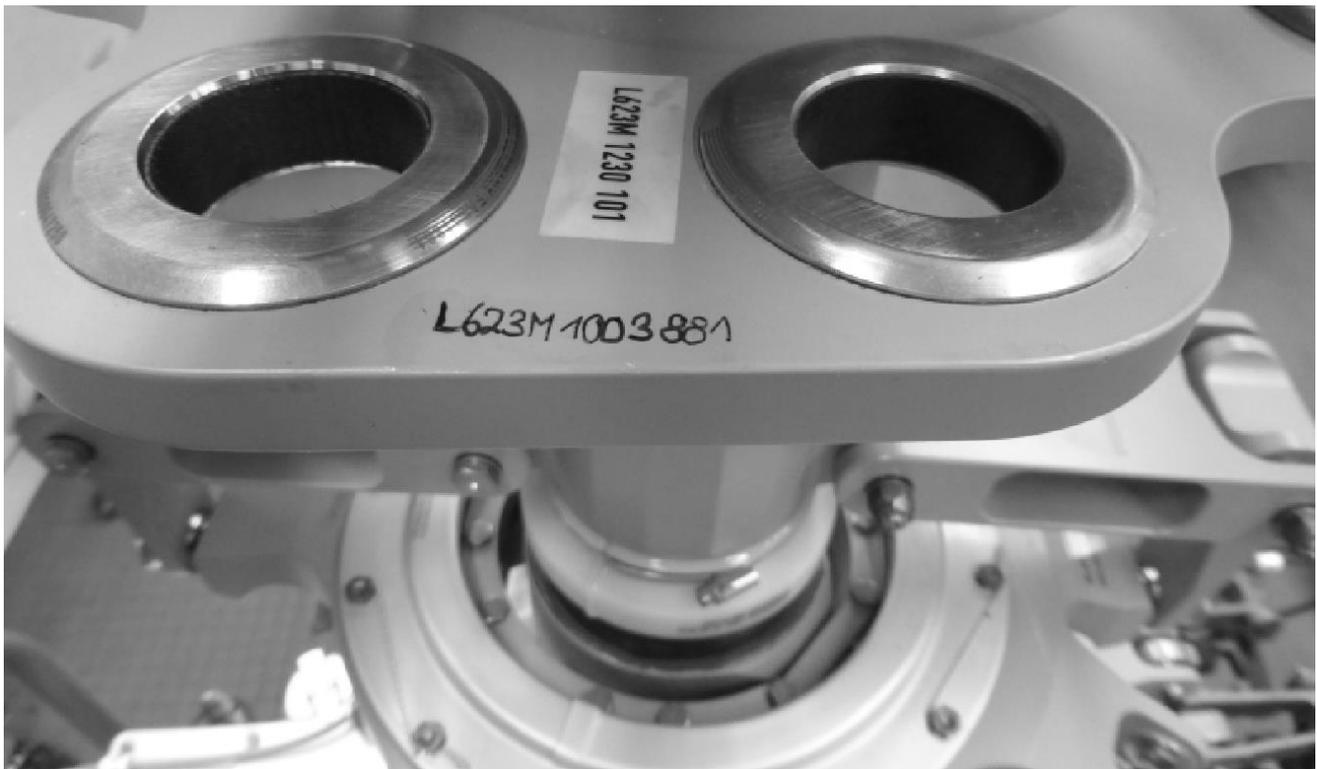
Appendix 4 – MRH additional identification

- (6) From 18 May 2012 [the effective date of the original issue of this AD], do not install a MRH with a P/N as listed in Appendix 2 of this AD and that has accumulated more than 400 FH since first installation on a helicopter unless that MRH has passed an inspection as required by paragraph (2) of this AD, or it is identified with “L623M1003881” (see Appendix 4 of this AD).

- (7.1) MRH shaft having a P/N as listed in Appendix 2 of this AD, which is identified with “L623M1003881” (see Note 2 and Appendix 4 of this AD).
- (7.2) MRH shaft having a P/N not listed in Appendix 2 of this AD.

Note 2: MRH shafts identified with “L623M1003881” have been modified in accordance with the instructions of AHD SB EC135-62-036 or reworked at AHD through drawing L623M1003881.
