## Airworthiness Directive

**AD No.:** 2017-0225

SCHROTH SAFETY PRODUCTS GmbH

### ATA 25 – Equipment / Furnishings – Seat Restraint Systems – AFM Amendment / Modification

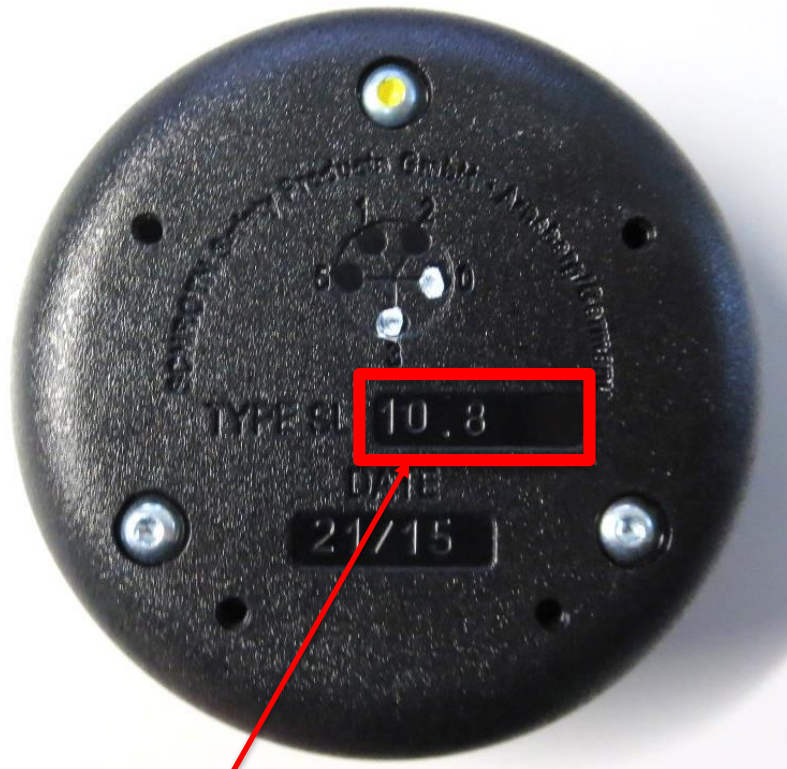
Figure 1 – Buckle Type identification

Buckle Type in this example is SL 10.8
