Federal
Aviation
Administration

Airworthiness Concern Sheet

<p>Reply to: Name: Kristi Bradley Title: Aviation Safety Coordinator Office: Operational Safety Branch Street Address: 10101 Hillwood Pkwy City, State, ZIP: Fort Worth, TX 76177 Telephone: 817-222-5485 Electronic Mail: Kristin.Bradley@faa.gov</p>	<p>Make: Cirrus Model / Series: SR20/SR22/SR22T Serial Numbers: Reason for Airworthiness Concern: Loss of Thrust Control due to Power Lever Failure</p>
---	--

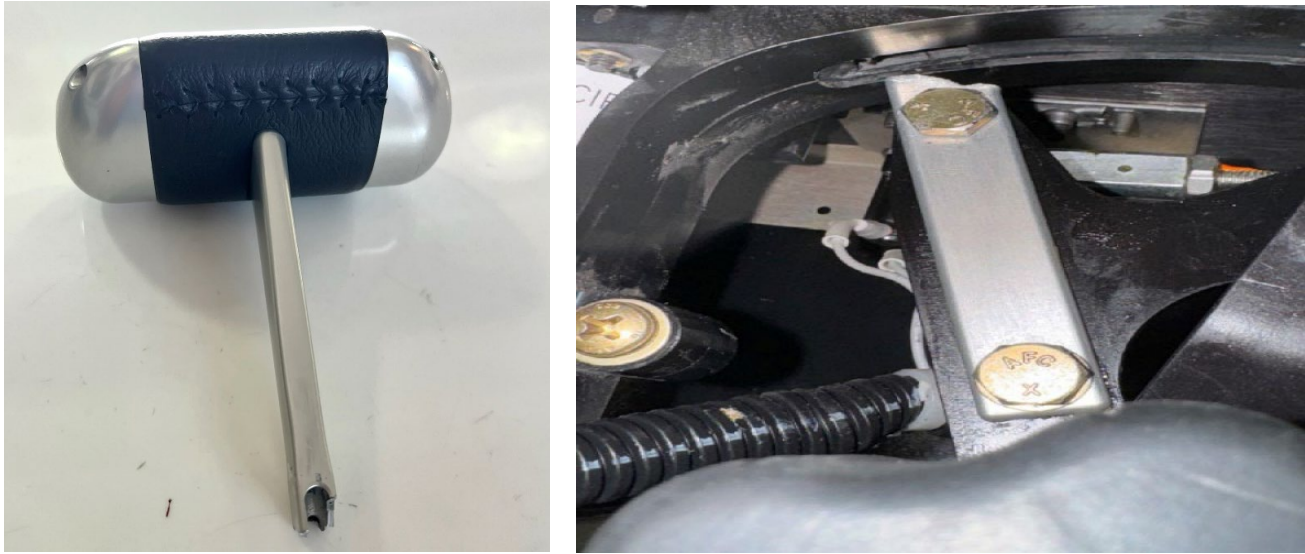
The FAA recently received a report of a power lever failure on a Cirrus SR20 airplane. While advancing to full throttle in preparation for takeoff, the power lever sheared and the pilot quickly cut fuel to the aircraft and aborted the takeoff. The fleet operator subsequently inspected the remainder of their aircraft and found cracks in 24 of the levers through visual and dye penetrant inspections. Time in Service for the fleet ranged from 2900 to 3900 hours. The aircraft are utilized in a training environment and contained on average 12,000 to 15,000 landings. The failure and cracks were noted to occur at the region of the lever that has the smallest cross section.

Figure 1. Upper power lever failure.

The FAA is interested in receiving any information on damage, cracks, or known failures observed on the power levers in Cirrus SR20/SR22/SR22T airplanes. We recommend operators inspect this area and please provide information including description of damage, available photos, airplane serial number, time in service, and any prior replacement of the throttle assembly or power lever.

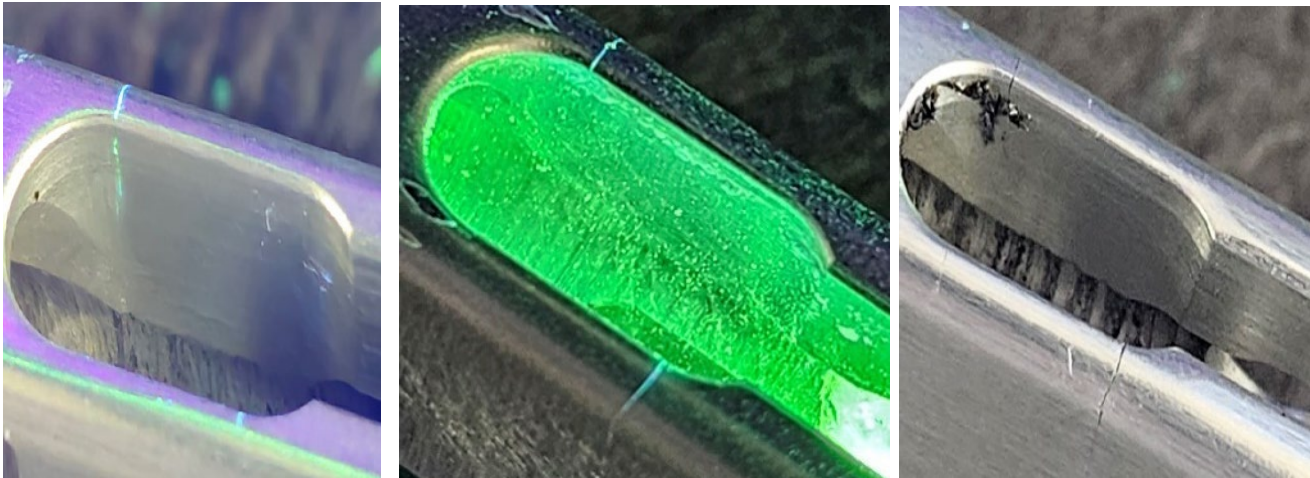
Figure 2. Sample cracks found with visual and fluorescent penetrant inspection.
