[Docket No. FAA-2023-2232; Project Identifier AD-2023-00943-R; Amendment 39-22681; AD 2024-04-02]

Airworthiness Directives; Robinson Helicopter Company Helicopters

Final rule.

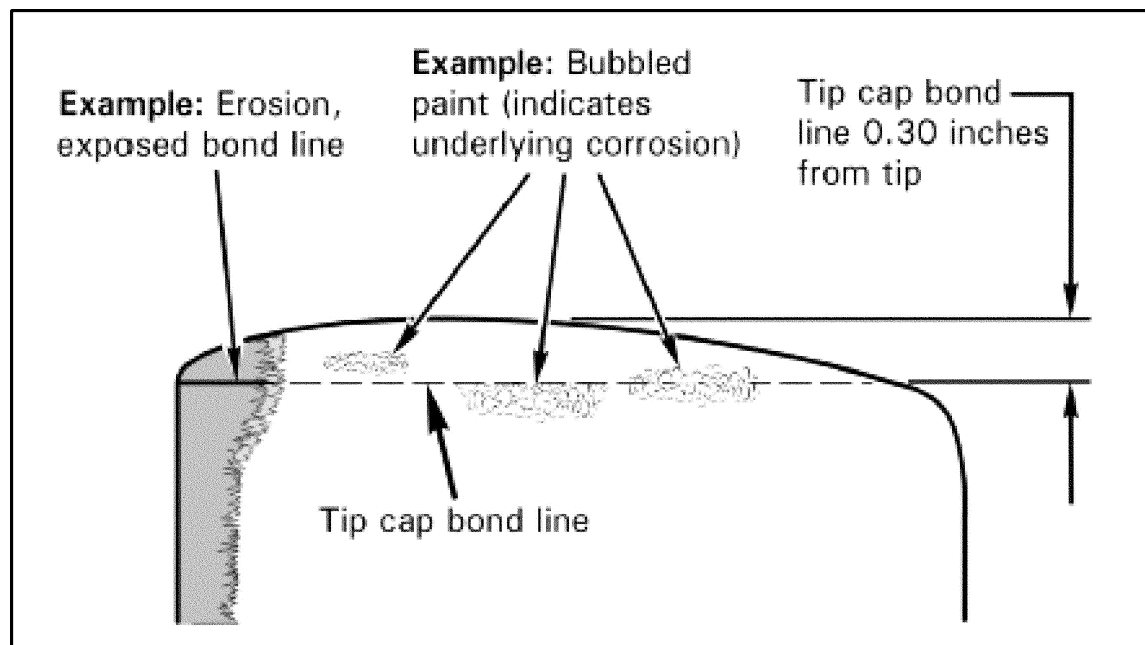
Figure 1 to Paragraph (g)(1)—TRB Tip Cap Check/Inspection

A debonded TRB tip cap can cause severe vibration and possible failure of the tail rotor gearbox housing. This condition, if not addressed, could result in increased vibrations, reduced controllability, and subsequent loss of control of the helicopter. The FAA is issuing this AD to address the unsafe condition on these products.

(1) Within 10 hours time-in-service (TIS) after the effective date of this AD and thereafter before the first flight of each day, visually check each TRB tip cap area (at and adjacent to the tip cap bond line

on each surface and edge of the TRB) for an exposed tip cap bond line or bubbled paint, as depicted in Figure 1 to paragraph (g)(1) of this AD. These items may indicate evidence of corrosion. The owner/operator (pilot) holding at least a private pilot certificate may accomplish this TRB tip cap check and must enter compliance with this paragraph of the AD into the helicopter maintenance records in accordance with [14 CFR 43.9\(a\)](#) and [91.417\(a\)\(2\)\(v\)](#). The record must be maintained as required by [14 CFR 91.417](#), [121.380](#), or [135.439](#).

(2) Within 100 hours TIS or during the next 100 hour or annual inspection after the effective date of this AD, whichever occurs first, and thereafter at intervals not to exceed 100 hours TIS or during the next 100 hour or annual inspection, whichever occurs first, visually inspect each TRB tip cap area (at and adjacent to the tip cap bond line on each surface and edge of the TRB) for evidence of corrosion, which may be indicated by an exposed tip cap bond line or bubbled paint, as depicted in Figure 1 to paragraph (g)(1) of this AD.

(3) As a result of the actions required by either paragraph (g)(1) or (2) of this AD, if there is evidence of corrosion, an exposed tip cap bond line, or bubbled paint, before further flight, remove all of the corrosion.
