# CIVIL AVIATION AUTHORITY CZECH REPUBLIC

### **AIRWORTHINESS DIRECTIVE**

#### Number: CAA-AD-001/2009

### AIRCRAFT - RUDDER CONTROL ROUTE - INSPECTION

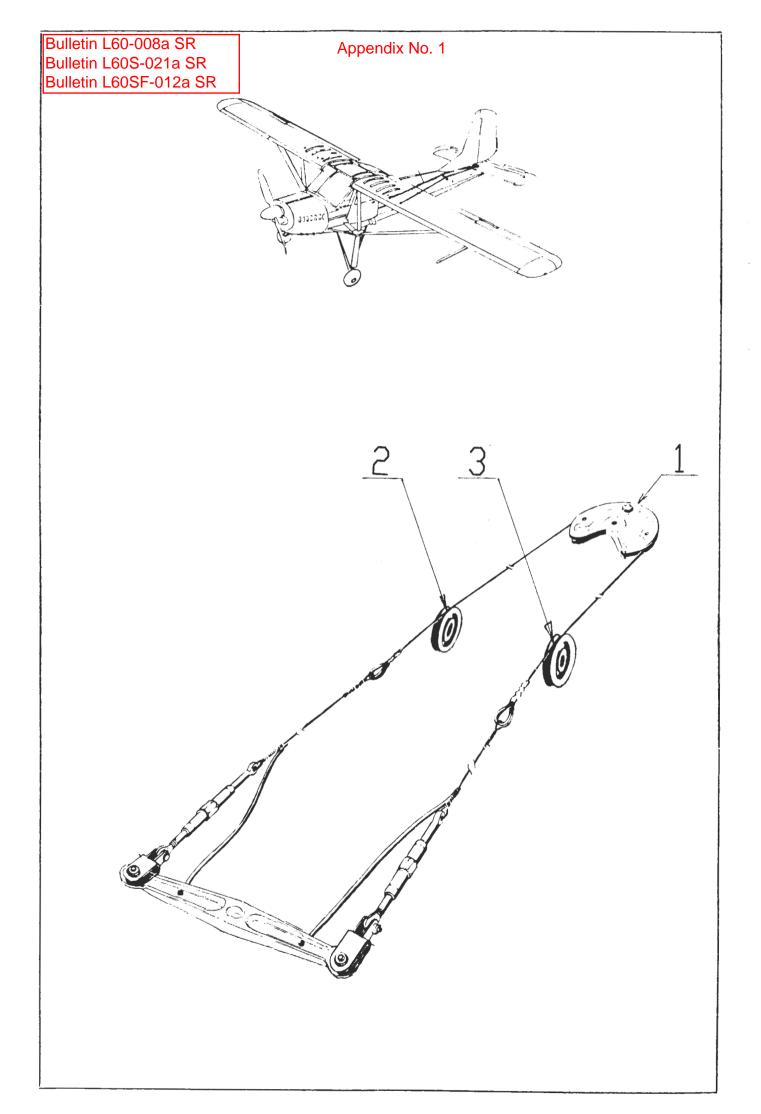
Appendix No. 1 Marking of enhanced check areas of cables 1, 2, 3.

**1. REFERRING TO:** L60 Brigadýr airplane, all types. 2. REASON: Possibility of excessive wear of the rudder control cable in the position of the rudder segment and failure of cable harness wires in the area of cable crossing on the pulleys. Possibility of stop screw loosening on the countershaft of foot control in the front part of the fuselage. 3. REQUIRED ACTION: Check of the rudder control route. 4. LATEST DAY OF ACTION: Immediately upon receiving the bulletin. 5. ACTION CARRIED OUT BY: Authorized operator's employee 6. INDUCED COST COVERED BY: Operator 7. NECESSARY MATERIAL: 8. WORK PROCEDURE: Check the complete route of the rudder control according to the following procedures: - Flight manual and operation instructions of the L60 airplane - chapter IV, point 1.10, Technical description and handling instructions of the L-60S airplane - part V, chapter 4, point 1.10, Flight manual for the L 60 SF- part IV, paragraph 1 Carefully check the areas defined in Appendix No. 1 of this bulletin. When checking connecting and stop screws, check
